PROPERTY INSPECTION REPORT

Concerning: _____ **1234 Main Street, Any City, TX 75...**
(Address or Other Identification of Inspected Property)

Property Condition Assessments: Baseline Property Condition Assessment Process using ASTM 2018 as a guide

Approximate Age:	21-30 years
Style:	Office
General Appearance:	Generally good condition
Main Entrance Faces:	South
Weather Condition:	Cloudy After Recent Rains
Temperature:	85-95 degrees

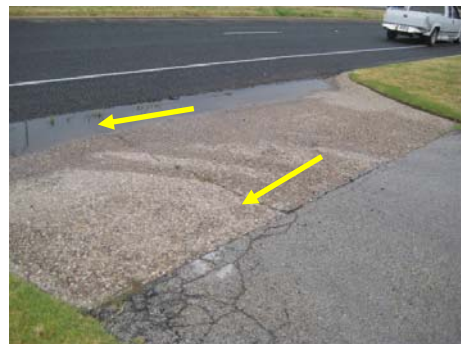
Comments:
The front entry at the Airport Freeway access road is somewhat cracked and is holding some water after recent rains. Recommend Repair.
The Asphalt parking at the front, East side and rear is in generally good condition. There is some typical cracking of the asphalt surface. Recommend seal coating the asphalt to protect it and mitigate any additional cracking due to aging.
The fencing on the West side of the building is somewhat damaged. Recommend Repair.

Figure 2 front entry from Airport Freeway

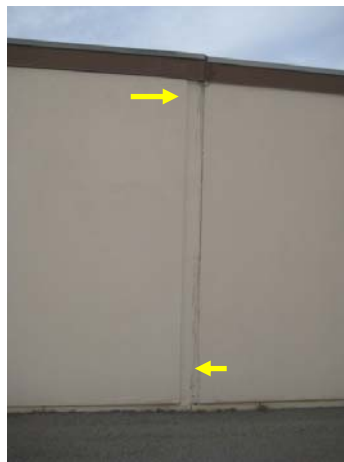
Minor separation between the front and rear portions of the building. A gap is present.

Expansion joint-East side.

Recommend sealing the gap with a flexible sealant to allow thermal expansion of the concrete. The gap may be the result of concrete pours at different times of construction. Recommend contacting the current owner for information on any additions or delays in construction.

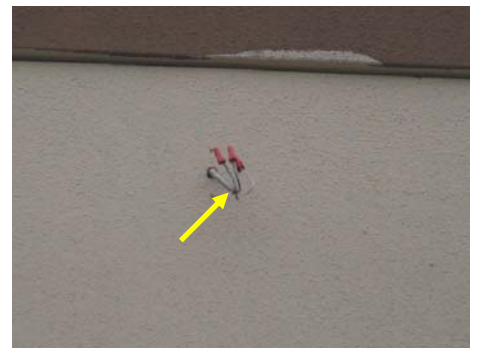
Missing light fixture/exposed wiring at the front upper exterior of the building. Recommend Repair.

Figure 9 Exposed wires/missing light front ext.

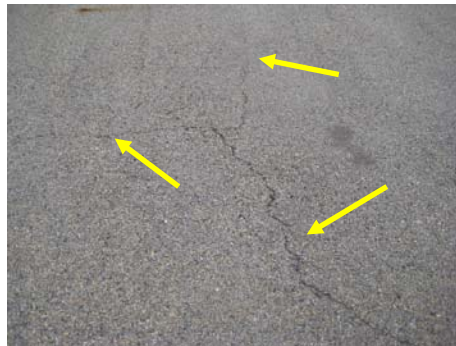
Figure 10 Common cracks in asphalt parking area

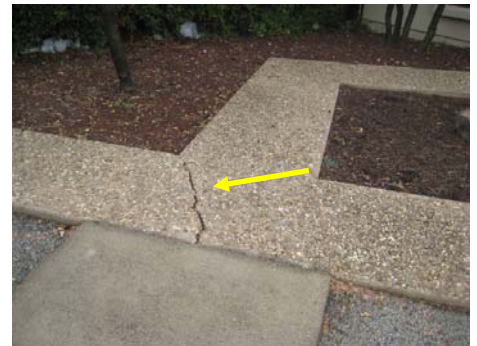
Comments:
The front sidewalk has some cracking. Recommend repair if this develops into a trip hazard.

Figure 11 Cracked sidewalk example-front

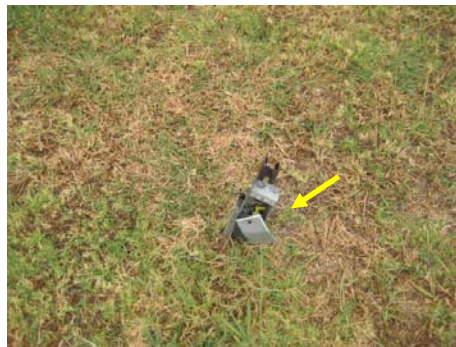
Missing junction box cover at the front parkway. Recommend Replacement.

Figure 12 Missing cover plate-front parkway

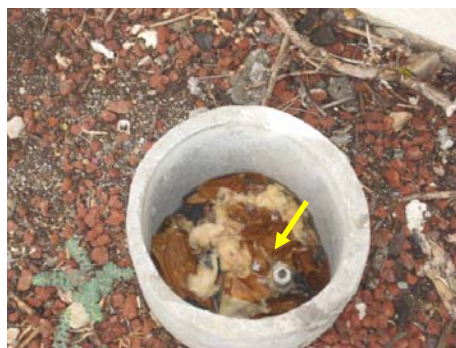
The hose connection(s) have a missing handle at the front of the building. Recommend replacement.

Figure 14 Missing handle at front hose connection

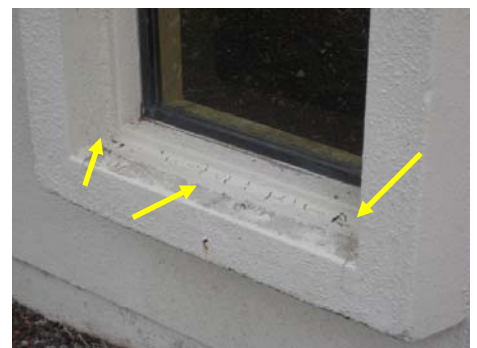
Some minor flaking exterior paint. Recommend repainting.

Figure 15 Minor flaking paint-example

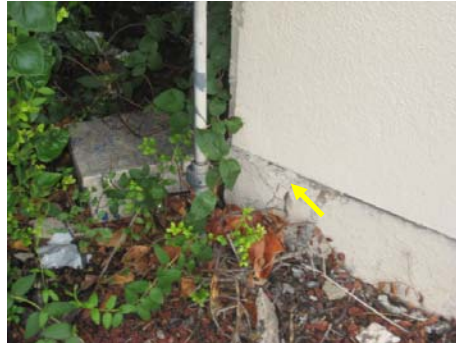
The concrete corners have some cracking at the Southwest corner of the building. This is a common condition caused by the lack of a bond break between the concrete and the brick mortar which would allow for the thermal expansion of the brick cladding. Recommend Monitoring and cosmetic repairs.

Figure 16 Corner crack- SW corner

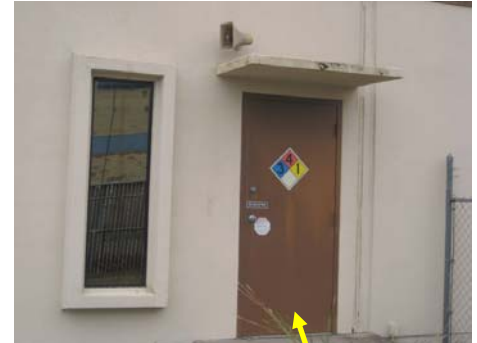
Comments:
EXTERIOR DOORS
The rear door auto closer is not connected. Recommend Repair.

Figure 17 Rear entry door

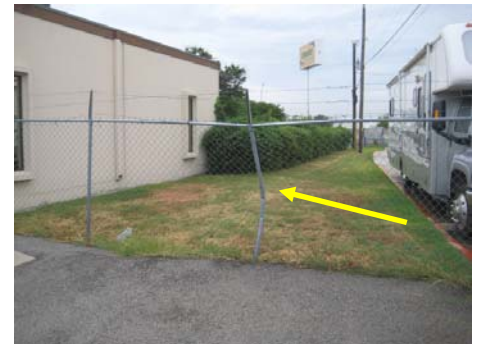
Figure 19 Damaged fence-West side rear

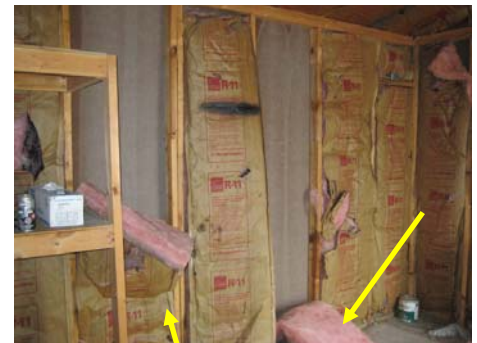
The interior insulation has fallen from the walls in several locations. Recommend Repair.

Figure 21 fallen insulation-rear storage building

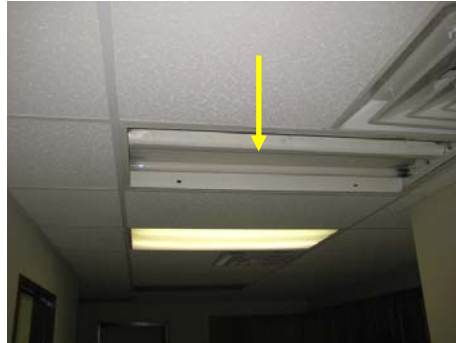
Missing or uninstalled light diffusers in various locations. Recommend installing the missing diffuser(s).

Figure 22 Missing light diffuser-example

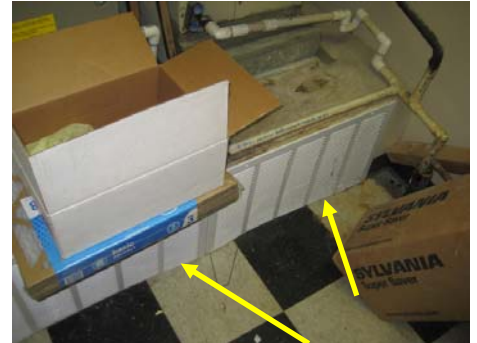
Return air should ideally not be drawn from a closet. Recommend further examination and repair as needed.

Figure 23 Return air in Closet

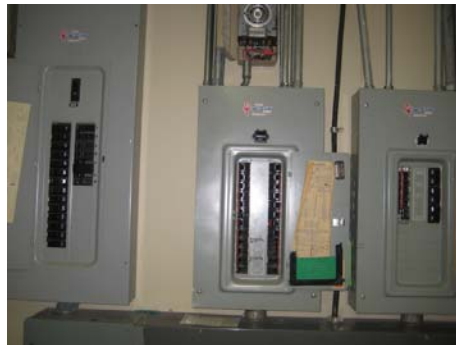
Figure 24 Panel boxes (L-R) 200 amp, 150 amp, 150 amp

Missing screws to secure the cover to the 200 amp panel box. Recommend Replacement.

The building is being served by older "Federal Pacific" panel boxes at the (2) 150 amp panel boxes. Due to the age of the panel boxes and the problems associated with this type of panel box, it is recommended that the owner of the building consider upgrading this panel box with a more current panel box.

A breaker is tripped and retrips when reset in the right 150 amp panel box. Recommend further examination and repair as needed.

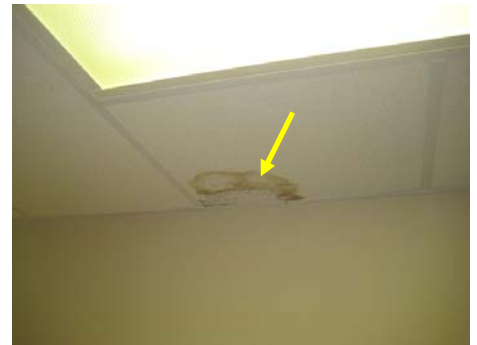
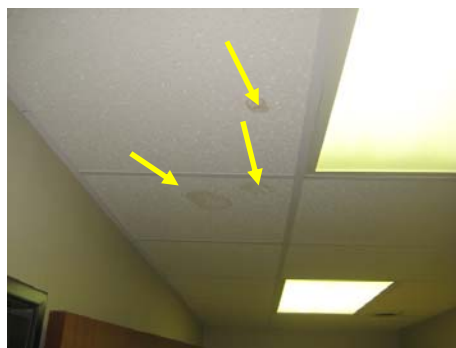
Comments: Ceilings: Metal Truss Framing. Ceiling Tiles. Floor Covering: Carpet, Vinyl,
Water staining was observed in a storage closet at the center of the building. The cause for the staining should be determined and repairs undertaken, if necessary, to prevent structural damage.

Figure 25 Water stain-Center storage closet

Figure 26 Water stain-Center storage closet
