PROPERTY INSPECTION REPORT

Concerning: 1234 Main Street Any City, TX 75...
(Address or Other Identification of Inspected Property)

By: Don Stafford TREC License #737 8/27/09
(Name and License Number of Inspector) (Date)

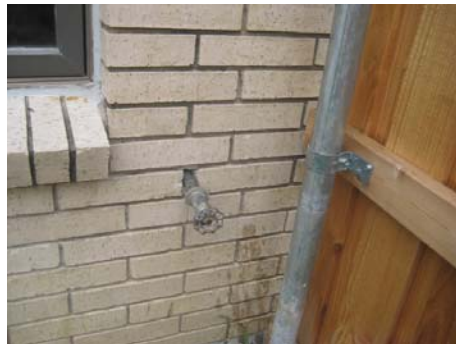
The hose connection(s) are not secured well to the exterior walls at the East side exterior of the house. Recommend repair.

Figure 1 Loose hose connection-East

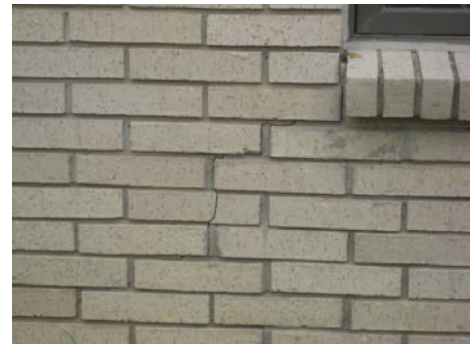
Slightly greater than anticipated cracking of the brick/mortar was observed at the East and West sides of the house. Although the amount of cracking does not suggest the need for foundation repair, Monitoring of this area is strongly encouraged. Recommend Monitoring for possible future repairs.

Figure 2 Cracked mortar/brick-East side

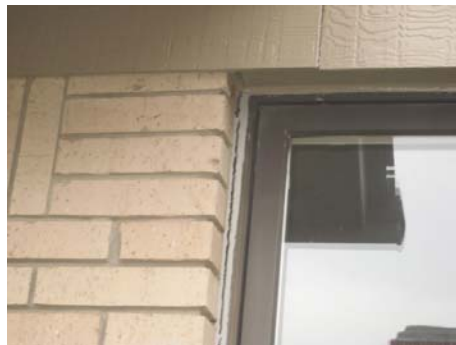
Some gaps were observed at the window openings along the East side of the house. This implies that some movement of the house has occurred, as is typical of most houses given the type of soils in the North Texas area..

Figure 3 Window gap-East side

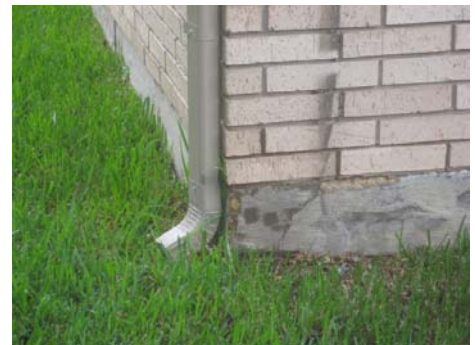
The gutters are missing splash blocks at various locations. Recommend replacement.

Figure 4 Missing gutter downspout splashblock

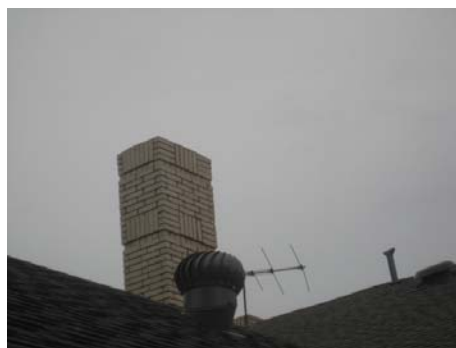
Figure 5 Missing chimney cap--rear

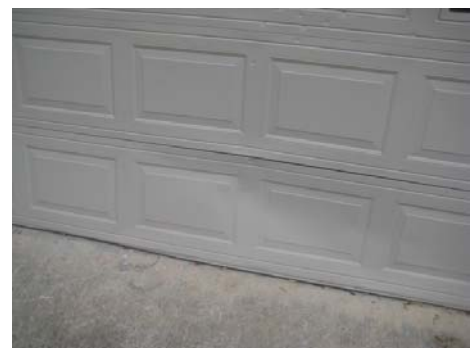
The garage door is damaged. Recommend repairs or replacement.

Figure 6 Damaged garage door

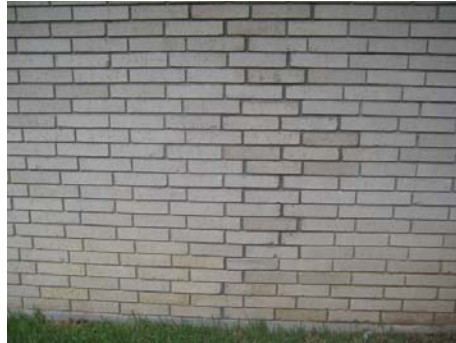
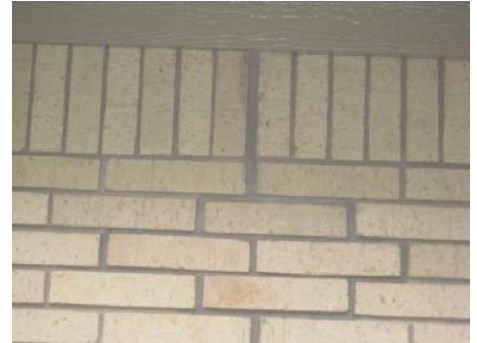
Repaired wall cracks in the brick/mortar in various locations. These are areas to be monitored for future movement and repointed/repared as needed.

Figure 7 Repaired mortar cracks-West side of garage

Figure 8 Repaired mortar cracks-West side of garage

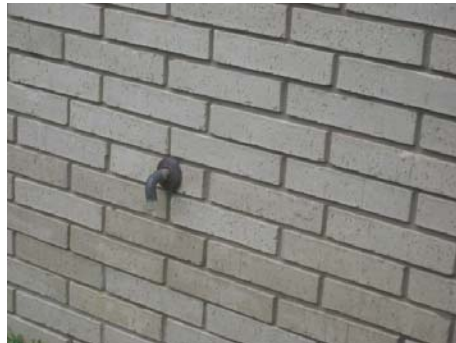
Figure 9 Water heater Temperature pressure relief line-too high-West side ext.

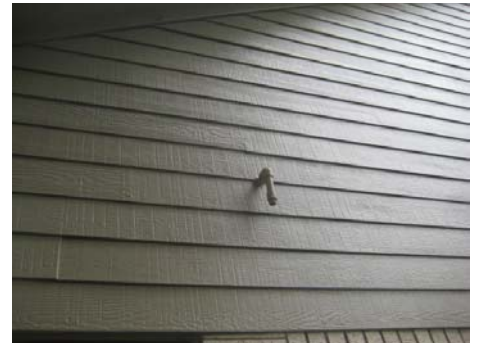
The Air conditioning System main air conditioning condensate drain line appears to be obstructed at the West side and living room units. The auxiliary drain pan has had water in it and/ the auxiliary drain line is running. Cleaning is needed.

Figure 10 West side auxiliary drain runs when AC runs

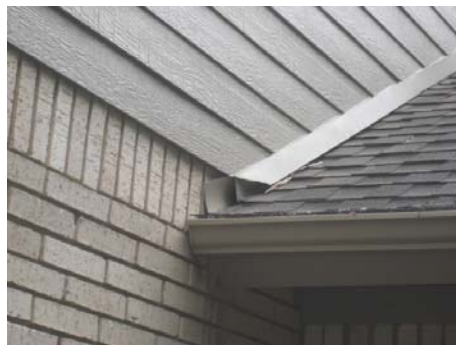
A gap in the sidewall flashing is present at the West side sidewall/roof joint. This may allow water penetration into the building. Recommend Repair.

Figure 11 Missing sidewall flashing-West side

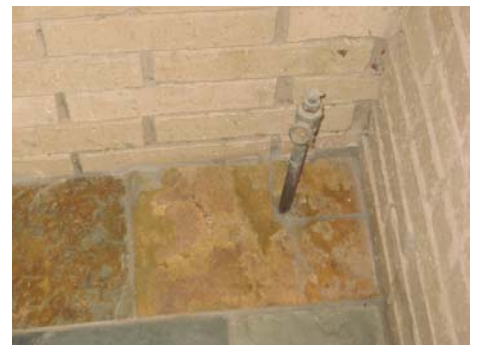
The hose connection(s) have a missing handle at the front porch. Recommend replacement.

Figure 12 Missing hose connection handle

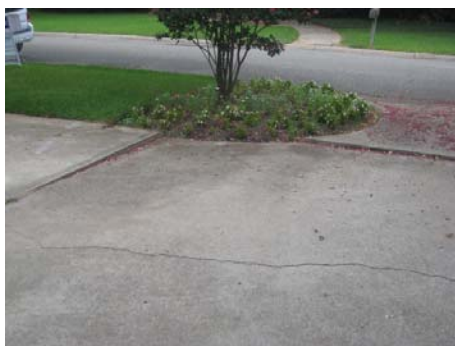
L. Other
Comments:
 The circular driveway at the front of the house has experienced significant settlement. This has allowed standing water to be present during heavy rains. A trip hazard also exists in this location. Recommend Repair.
 Normal/typical cracking of the alley driveway is present. Recommend Monitoring.

Figure 13 Settled/damaged driveway-front

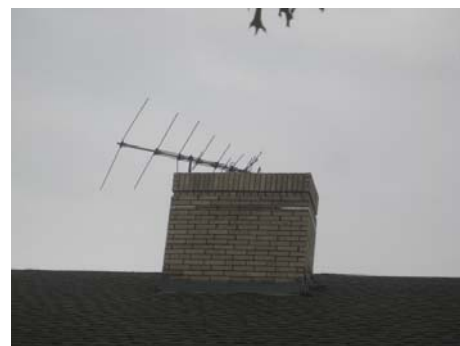
Figure 14 Missing fireplace chimney cap-front

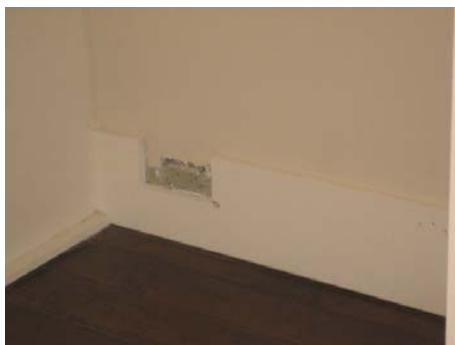
Missing outlet cover plates in the kitchen (refrigerator). Recommend installing the missing cover plates.

Figure 15 Missing refrigerator receptacle cover

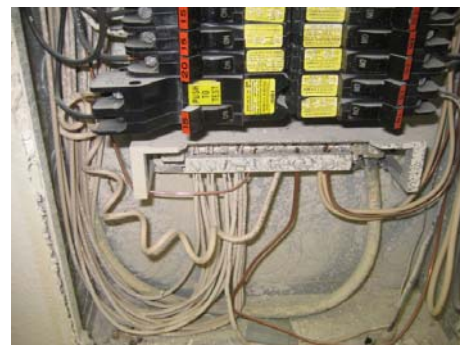
The ground buss bar and the Neutral buss bar should be separated in the subpanel box(es) at the East hall clothes closet. Neutral wires are not allowed to touch the ground buss bar in subpanel boxes. The ground bonding is through the main panel box not the subpanel box(es).

Figure 16 Ground/Neutrals not separated sub box-Hall closet

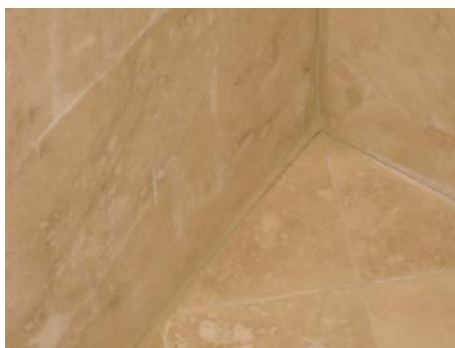
Figure 17 Master bath shower cracked grout

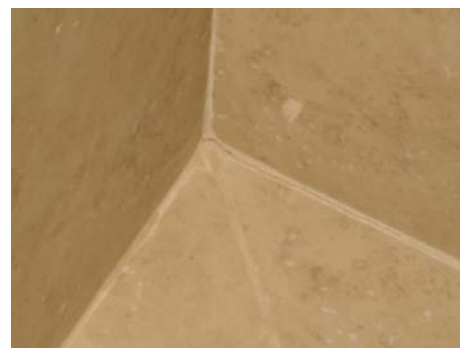
Cracked, deteriorated and/or missing shower stall grout and caulk at the upstairs bath. Recommend Repair.

Figure 18 Upstairs shower cracked tile grout

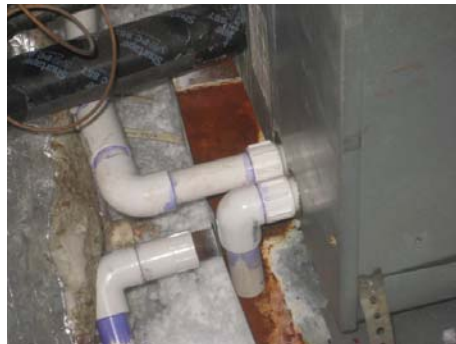
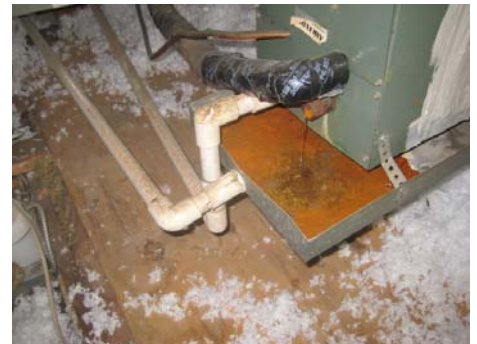
Figure 19 East AC unit-pan holds water

Figure 20 East AC unit-pan holds water

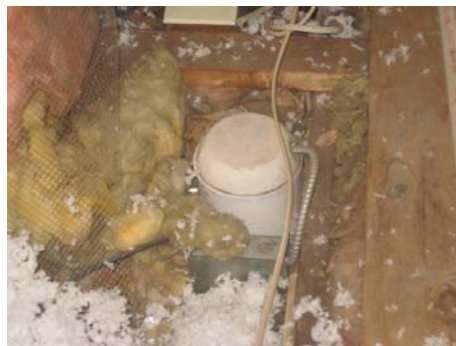
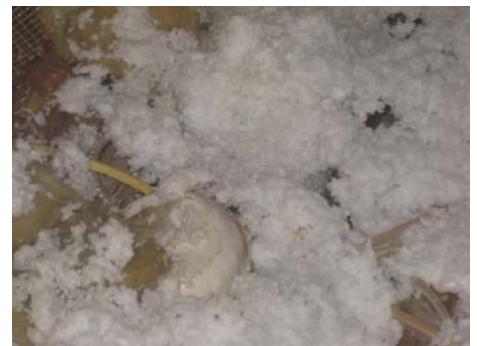
Recessed light fixtures that are installed in insulated ceilings can represent a fire hazard if they are not suitably rated for this application or protected from direct contact with the insulation in the attic. The lights are not rated to be in contact with the insulation. Recommend removing insulation from around these recessed light fixtures or replacing the light fixture.

Figure 21 Recessed lights touching insulation

Figure 22 Recessed lights touching insulation
