Property Condition Assessment

Report Date: October 14, 2019

Property Address: 1234 Main Street
Cedar Hill, TX 75104

Prepared By: Stafford Inspections
2328 Southwood Dr.
Dallas, TX 75224

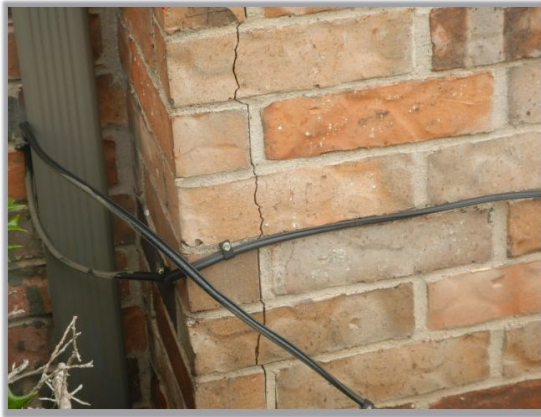
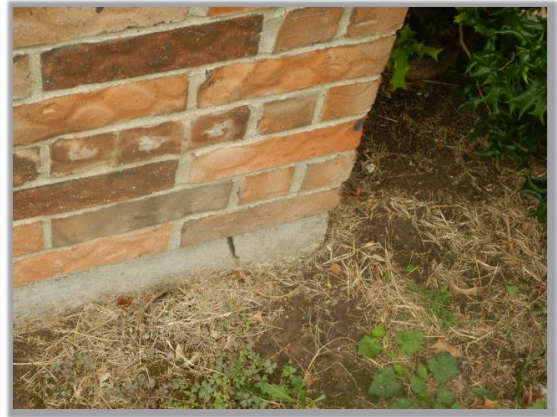
Some vertical cracking of the masonry is present Various Locations. This is typically an indication of movement due to the thermal expansion and contraction of the brick cladding. Recommend cosmetic repairs and monitoring for possible future structural repairs.

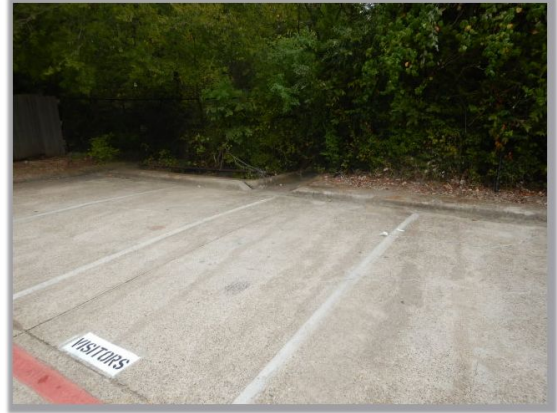
The grading should be improved to promote the flow of storm water away from the structure-- Various Locations. This can usually be accomplished by the addition of top soil, or guttering. The ground should ideally slope away from the structure 6" for the first ten feet.

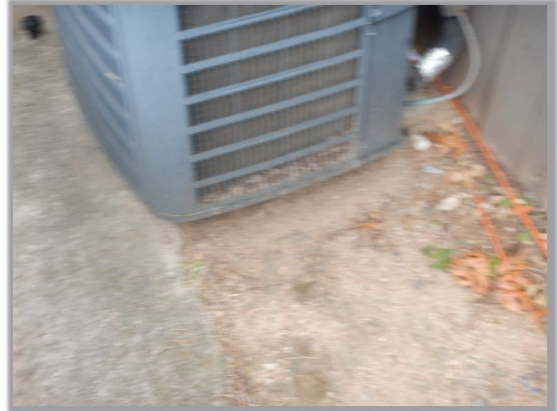
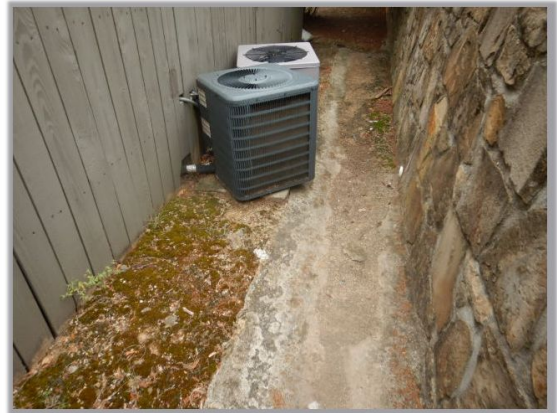
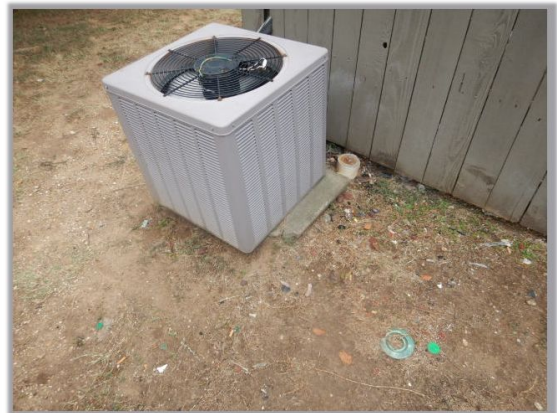
Many of the units are not sitting squarely on the concrete pads. Some of the pads are too small for the unit. Ideally, the unit pads should be replaced when replacing the units.

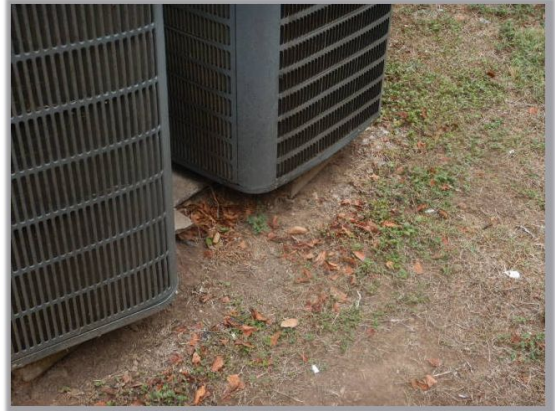
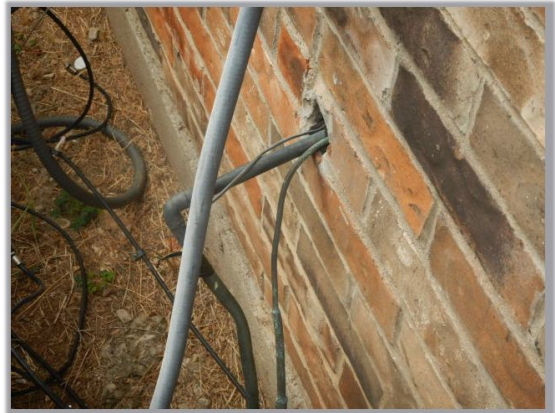
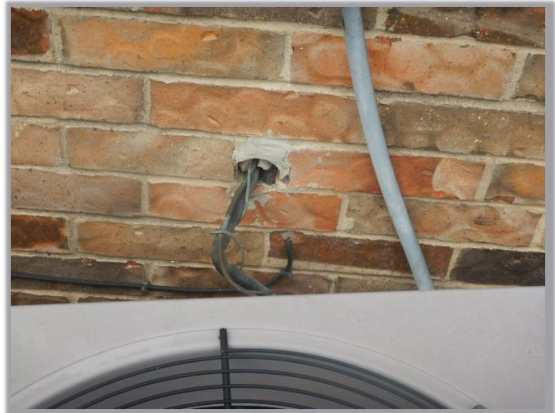
Missing/Damaged insulation on refrigerant lines --at Many Locations. Recommend repair or replacement.

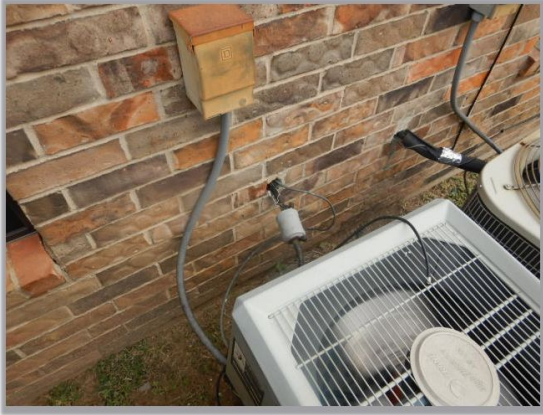
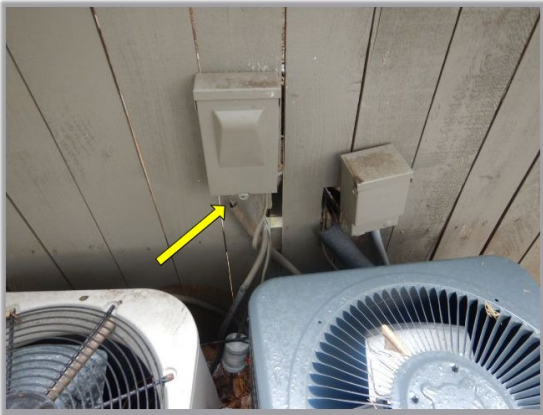
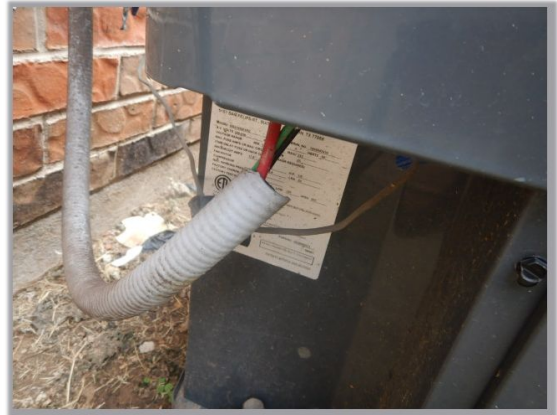
Damaged conduit at some of the AC condensers. Recommend repair or replacement as needed.

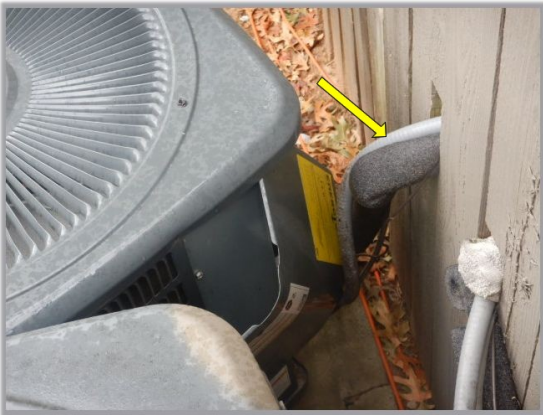
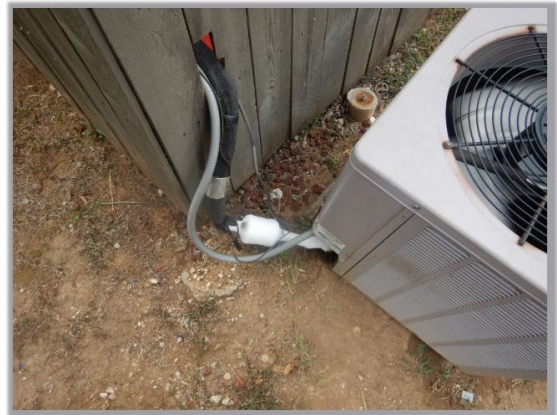
The Air Conditioning System has icing of the evaporator coil/ suction line at some of the units. (Approximately 4 were observed) Recommend further examination and repair as needed.

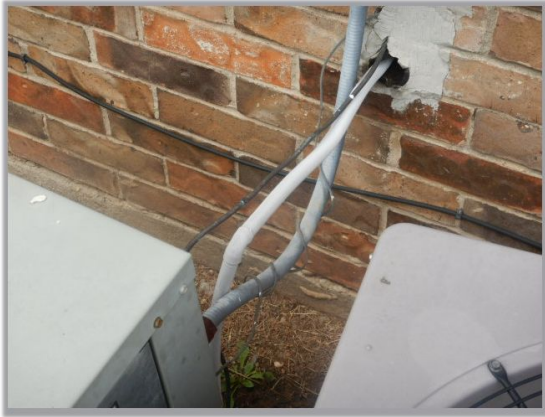
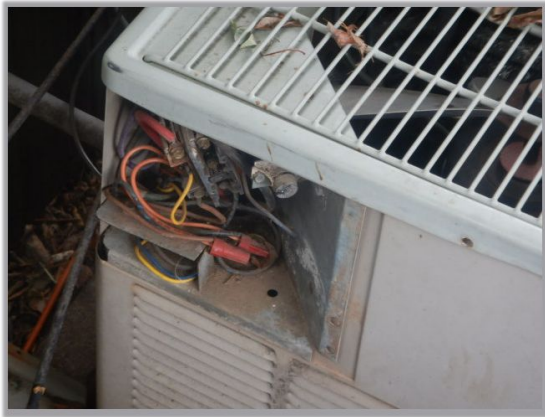
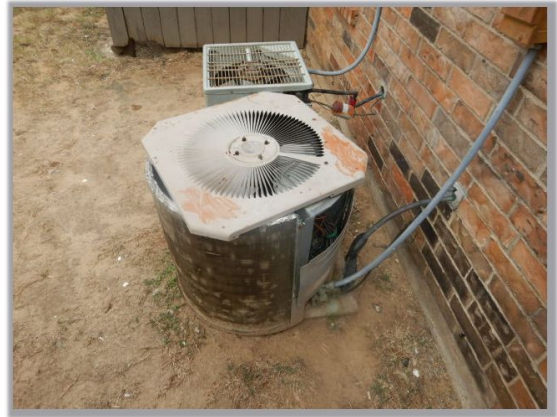
Some of the units have damaged condenser cabinets. Recommend repair.

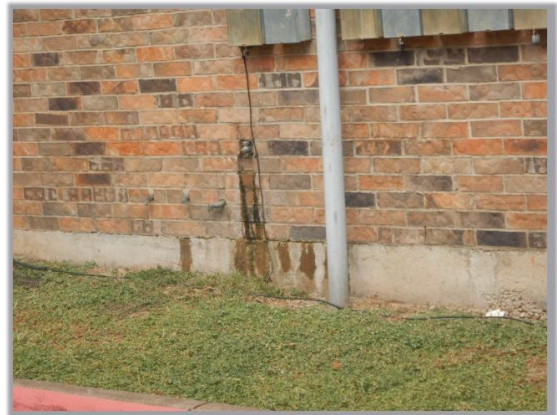
Supply Piping
Hose bibs are leaking at Building C , D and E. Recommend repair or replacement as needed.

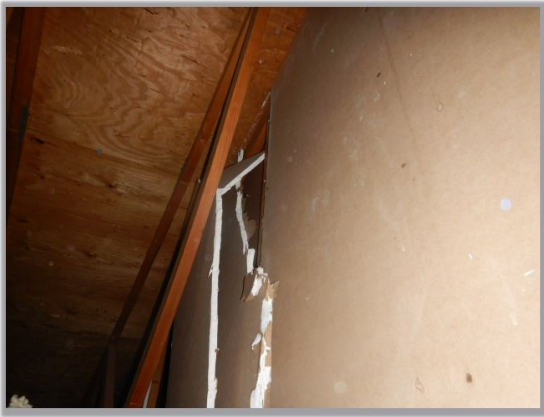
Damage to the firewall between units in the attic. Observed at Unit 6B.

Recommend examination and repair of any damage to the fire wall separation in the attic. Approximate cost \$6,000

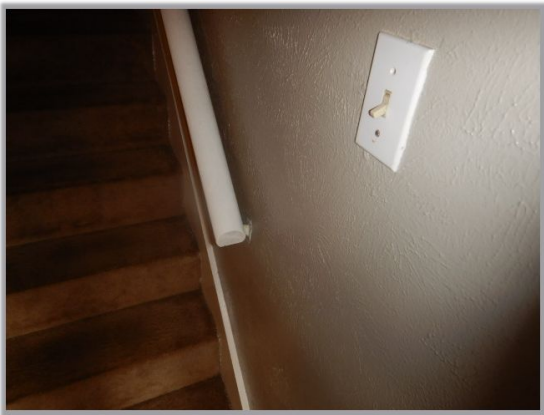
The stairway handrail should have a turnback at the top and bottom ends of the stairway handrail in order to meet current building standards. (Turnbacks are where the ends of the handrail turn back to the wall to prevent snagging.) Recommend Repair.

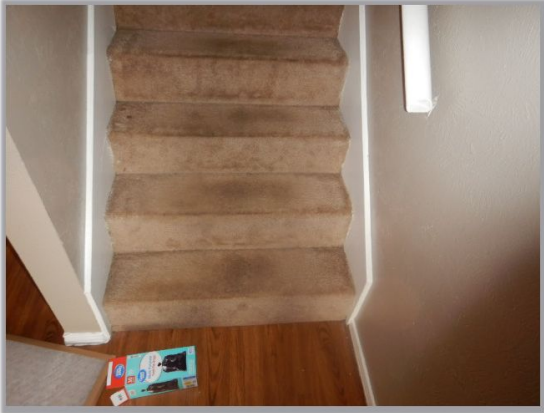
The stair treads are somewhat non-standard. The treads are less deep than are required. (Minimum 10 inches) Recommend further examination and repair or replacement as needed.

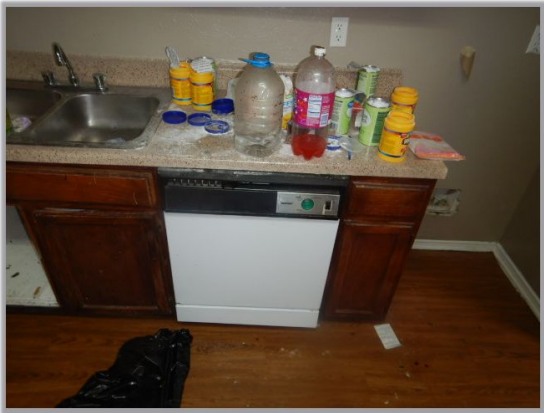
Damaged dishwasher control. Recommend repair or replacement as needed.

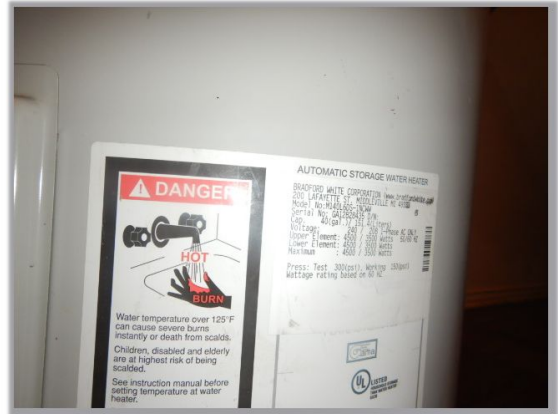
Water Heater Description and Location: Electric 240 volt 40 Gallons Closet under stairway 2015

The water heater does not have a safety pan. Recommend installing a safety pan to prevent damage.

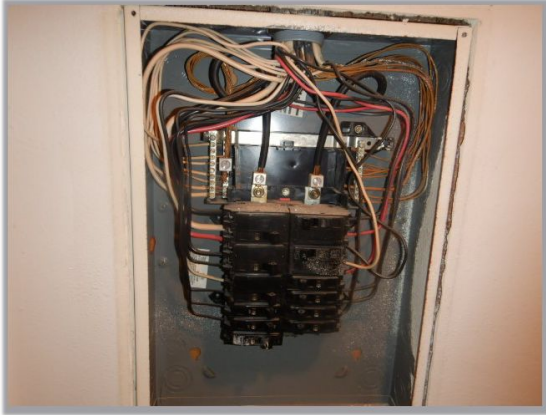
There is inadequate clearance at the front and sides of the panel box. Recommend relocating the panel box for increased safety and to conform to current building standards.

The ground buss bar and the Neutral buss bar should be separated in the subpanel box(es). Neutral wires are not allowed to touch the ground buss bar in subpanel boxes. The ground bonding is through the main panel box not the subpanel box(es). Recommend further examination and repair as needed.

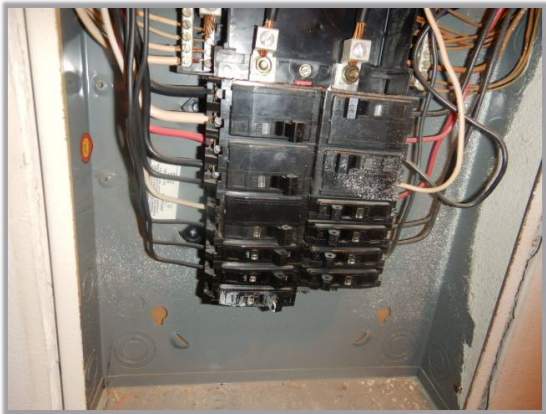
Wiring in the panel box(es) is not properly identified. Some white insulated wires are being used as ungrounded "hot" circuits. Ideally, the wiring should be properly identified with appropriately permanent markings, (electricians tape or other means). Recommend repair.

Multiple neutral wire connections were located under a single screw at the panel box. CURRENT building standards do not allow this type of electrical connection. Recommend further evaluation and repair as needed.

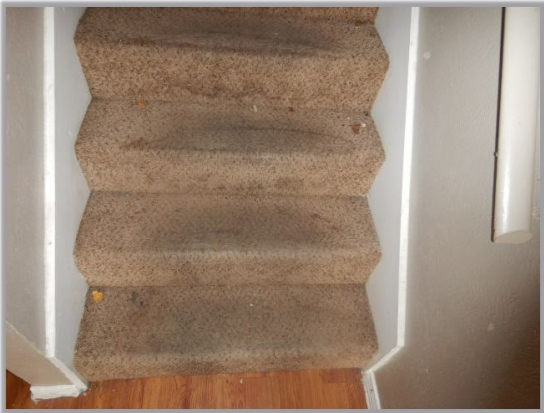
The stair treads are somewhat non-standard. The treads are less deep than are required. (Minimum 10 inches) Recommend further examination and repair or replacement as needed.

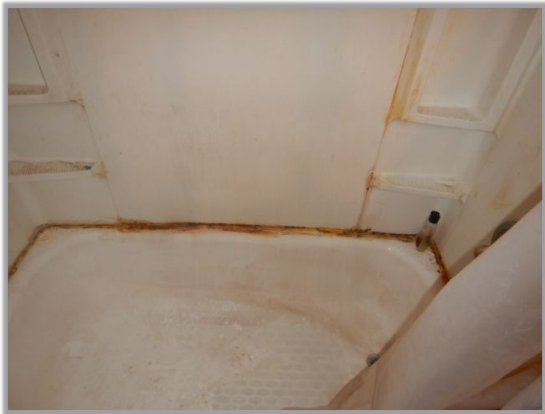
the bathtub surround has some mildew. Recommend cleaning.

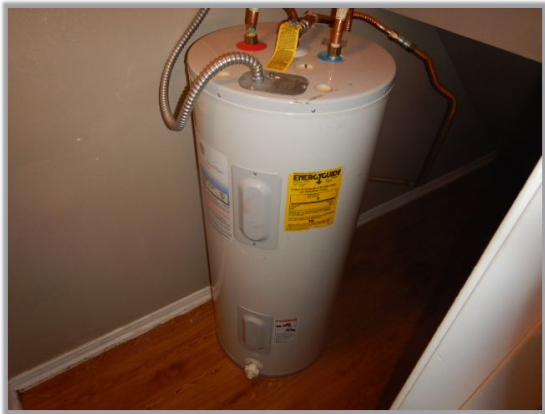
Water Heater Description and Location: Electric 240 volt 40 Gallons Closet under stairway 2007

The water heater does not have a safety pan. Recommend installing a safety pan to prevent damage.

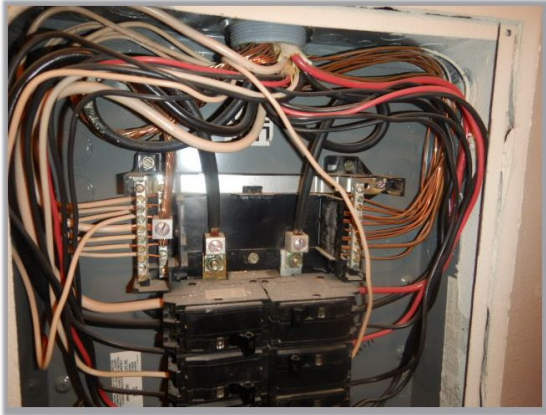
Wiring in the panel box(es) is not properly identified. Some white insulated wires are being used as ungrounded "hot" circuits. Ideally, the wiring should be properly identified with appropriately permanent markings, (electricians tape or other means). Recommend repair.

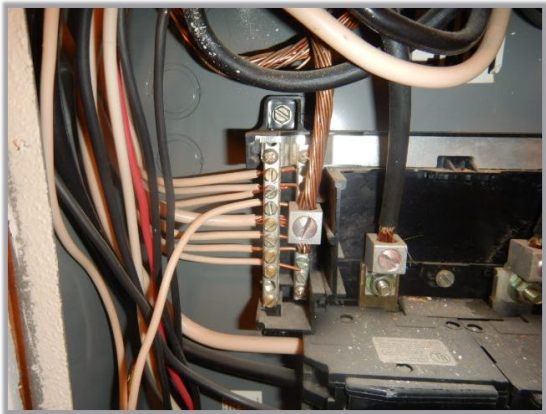
Multiple neutral wire connections were located under a single screw at the panel box. CURRENT building standards do not allow this type of electrical connection. Recommend further evaluation and repair as needed.

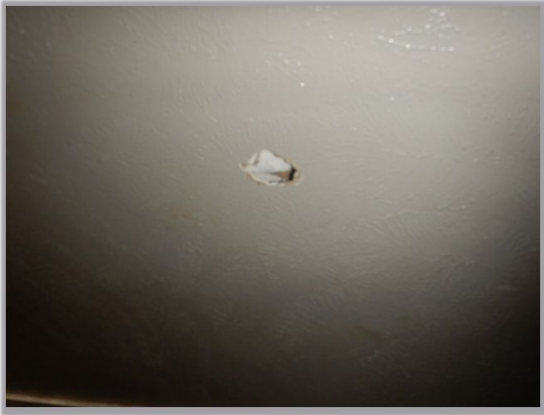
Damaged wall at the hallway. Recommend repair.

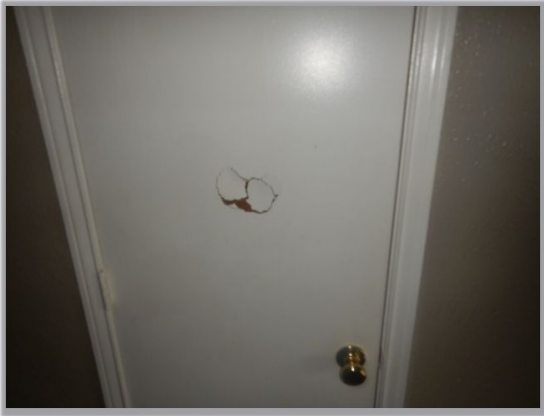
Damaged closet door. Recommend repair or replacement as needed.

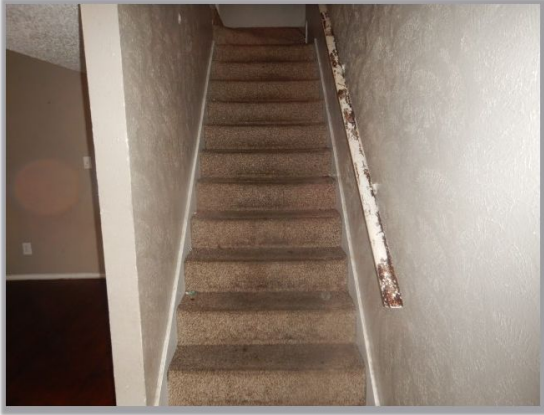
The stairway handrail should have a turnback at the top and bottom ends of the stairway handrail in order to meet current building standards. (Turnbacks are where the ends of the handrail turn back to the wall to prevent snagging.) Recommend Repair.

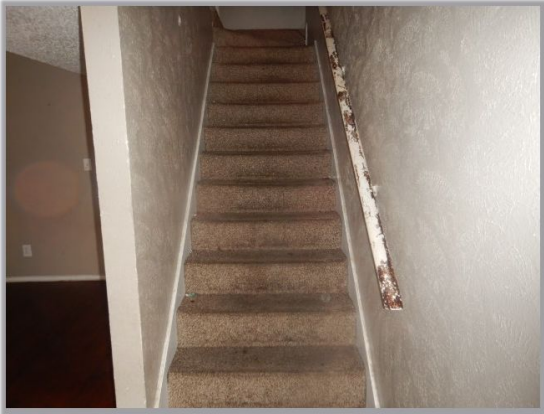
The stair treads are somewhat non-standard. The treads are less deep than are required. (Minimum 10 inches) Recommend further examination and repair or replacement as needed.

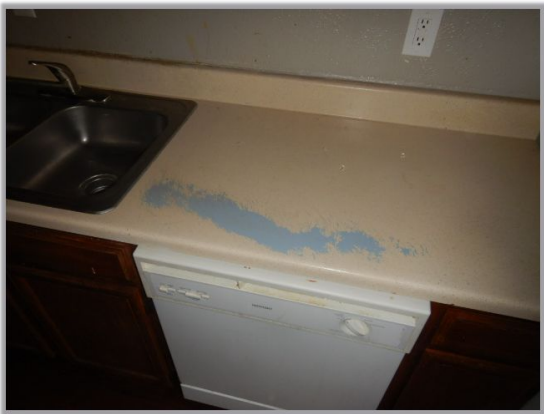
Damaged kitchen counter. Flaking paint. Recommend repair.

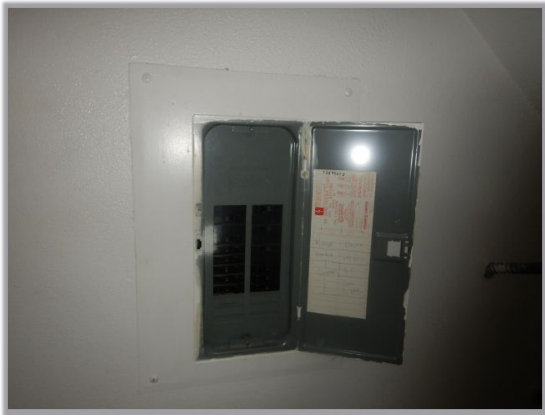
There is inadequate clearance at the front and sides of the panel box. Recommend relocating the panel box for increased safety and to conform to current building standards.

The ground buss bar and the Neutral buss bar should be separated in the subpanel box(es). Neutral wires are not allowed to touch the ground buss bar in subpanel boxes. The ground bonding is through the main panel box not the subpanel box(es). Recommend further examination and repair as needed.

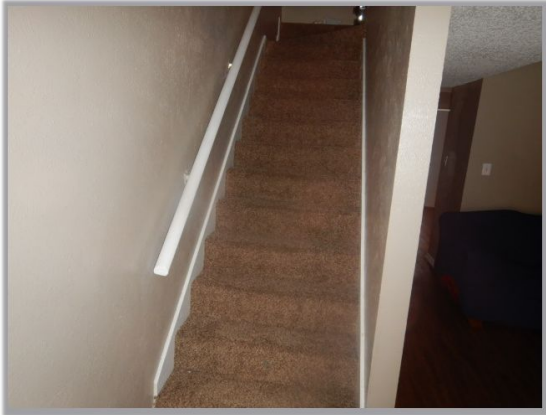
The stairway handrail should have a turnback at the top and bottom ends of the stairway handrail in order to meet current building standards. (Turnbacks are where the ends of the handrail turn back to the wall to prevent snagging.) Recommend Repair.

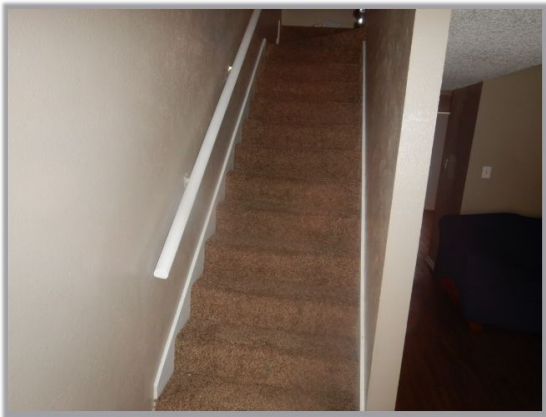
The stair treads are somewhat non-standard. The treads are less deep than are required. (Minimum 10 inches) Recommend further examination and repair or replacement as needed.

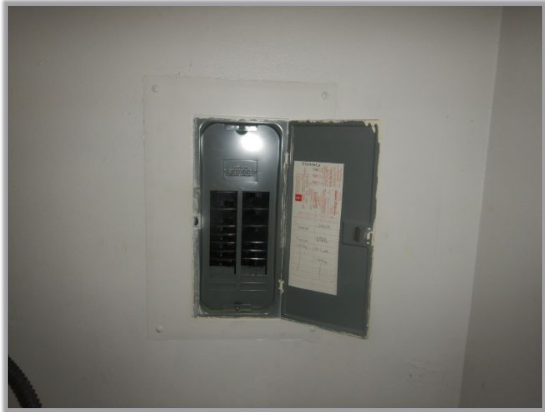
There is inadequate clearance at the front and sides of the panel box. Recommend relocating the panel box for increased safety and to conform to current building standards.

The ground buss bar and the Neutral buss bar should be separated in the subpanel box(es). Neutral wires are not allowed to touch the ground buss bar in subpanel boxes. The ground bonding is through the main panel box not the subpanel box(es). Recommend further examination and repair as needed.

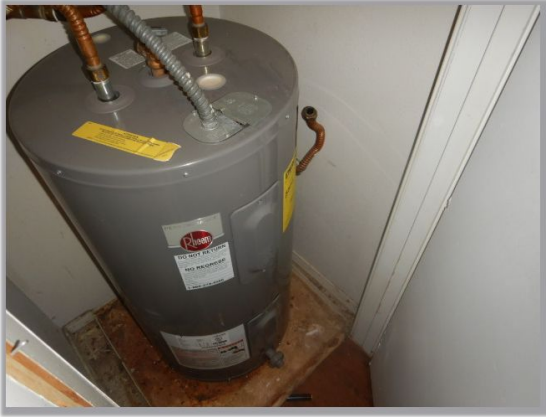
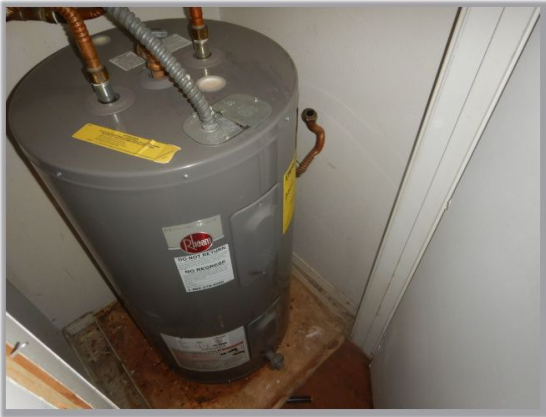
The water heater does not have a safety pan. Recommend installing a safety pan to prevent damage.

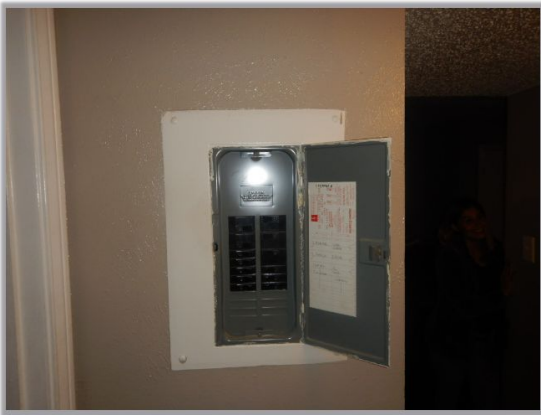
The ground buss bar and the Neutral buss bar should be separated in the subpanel box(es). Neutral wires are not allowed to touch the ground buss bar in subpanel boxes. The ground bonding is through the main panel box not the subpanel box(es). Recommend further examination and repair as needed.

Wiring in the panel box(es) is not properly identified. Some white insulated wires are being used as ungrounded "hot" circuits. Ideally, the wiring should be properly identified with appropriately permanent markings, (electricians tape or other means). Recommend repair.

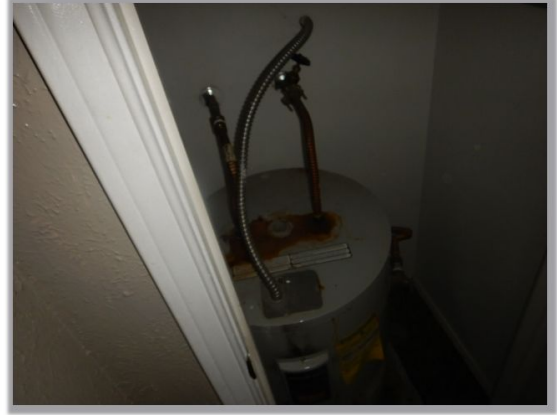
Water Heater Description and Location: Electric 240 volt (Being replaced. Leaking)

The water heater does not have a safety pan. Recommend installing a safety pan to prevent damage.

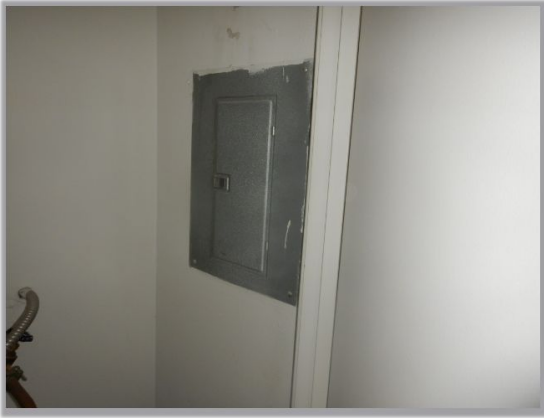
The ground buss bar and the Neutral buss bar should be separated in the subpanel box(es). Neutral wires are not allowed to touch the ground buss bar in subpanel boxes. The ground bonding is through the main panel box not the subpanel box(es). Recommend further examination and repair as needed.

Wiring in the panel box(es) is not properly identified. Some white insulated wires are being used as ungrounded "hot" circuits. Ideally, the wiring should be properly identified with appropriately permanent markings, (electricians tape or other means). Recommend repair.

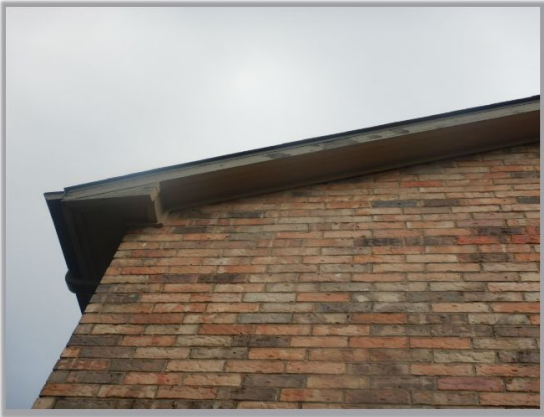
Minor flaking exterior paint-- Various Locations Building A The structure should be scraped, primed and repainted to protect the wood/siding/trim.

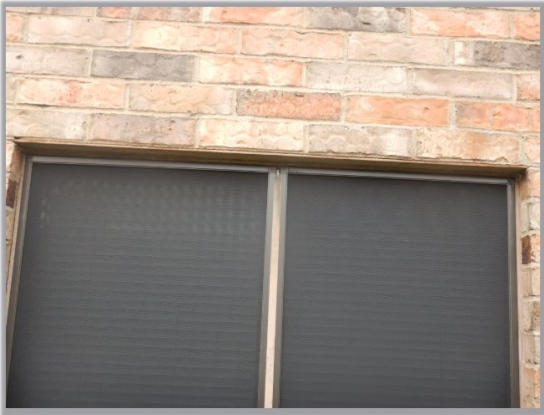
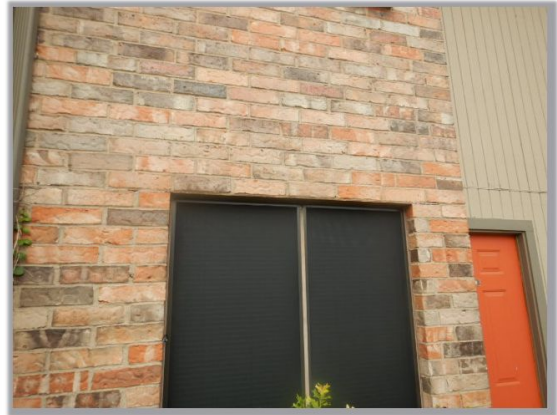
The lintels (metal support for the masonry over windows and doors) are rusting somewhat Various Locations. Recommend Repair/painting to prevent rusting of the lintels and possible cracked masonry mortar.

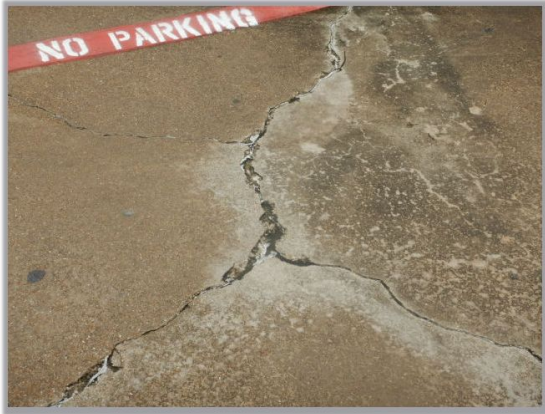
Minor damage to the concrete parking areas. Recommend spot repairs.

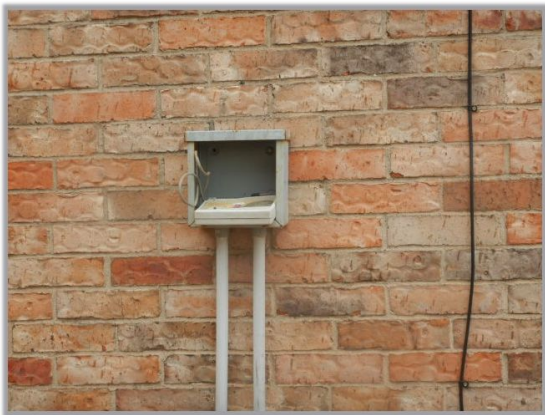
the sprinkler system is disabled. Not being used.

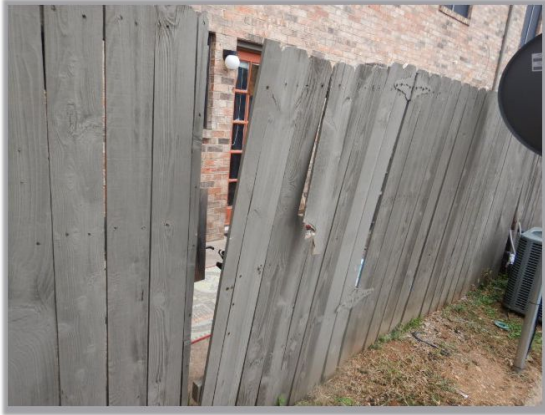
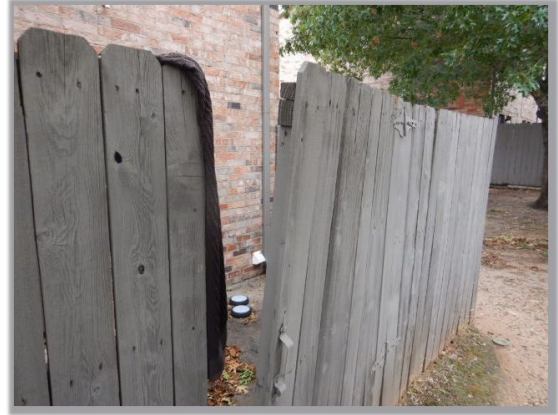
Damaged fencing at the rear of buildings A, B, C. Recommend repair or replacement as needed.

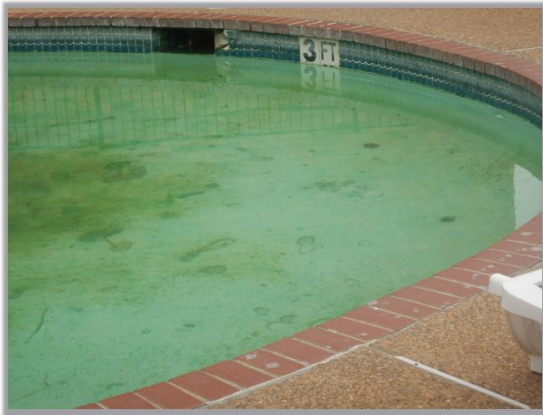
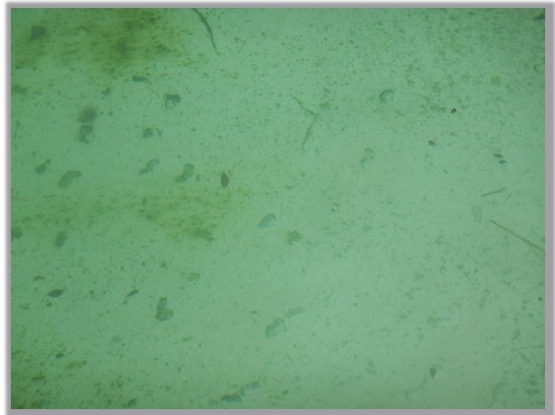
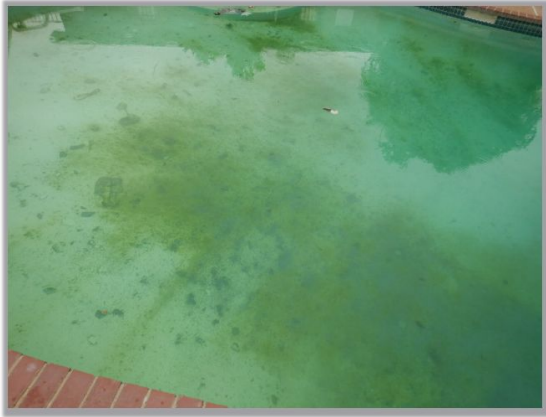
The pool plaster/surface is deteriorated. The pool surface is aging. Recommend further examination to determine what solutions are available as well as costs to repair/replace the pool surface/plaster.

Recommend repairing/replacing the pool surface. Approximate cost \$4,000

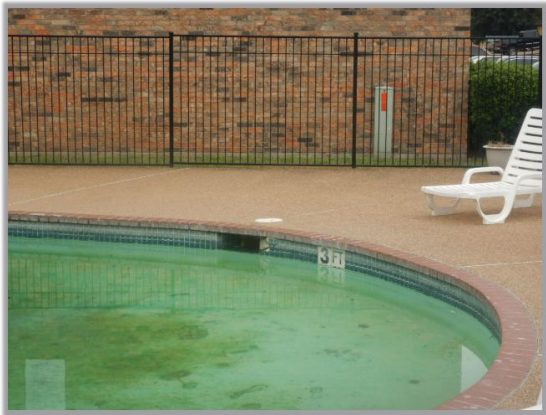
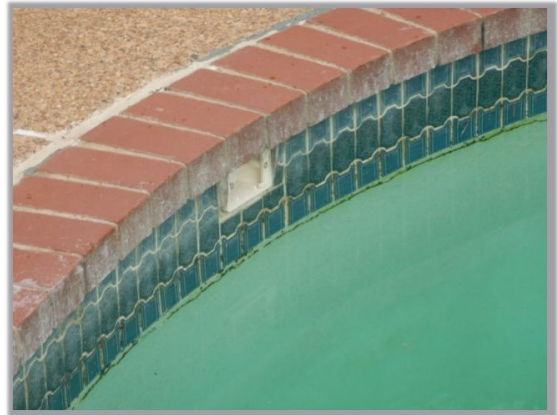
Missing tiles at the pool edge. Recommend replacement.

Recommend replacing the missing tile. Approximate cost \$125
