Property Condition Assessment

Report Date: February 6, 2020

Property Address: 1234 Main Street
Garland, TX

Prepared By: Stafford Inspections
2328 Southwood Dr.
Dallas, TX 75224

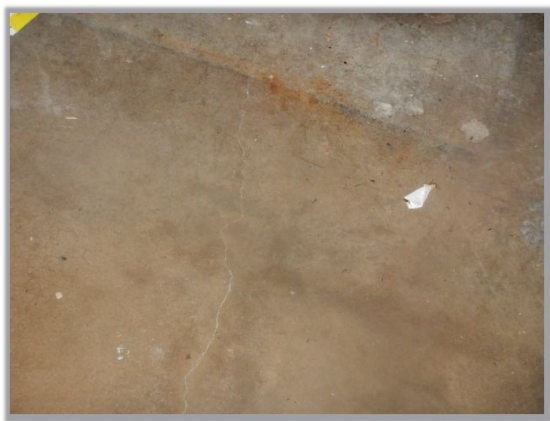
Some minor cracking of the slab floor is present--Open Bay-1121. The amount of cracking does not suggest a serious structural problem. This area should be monitored for additional movement and possible future structural repairs.

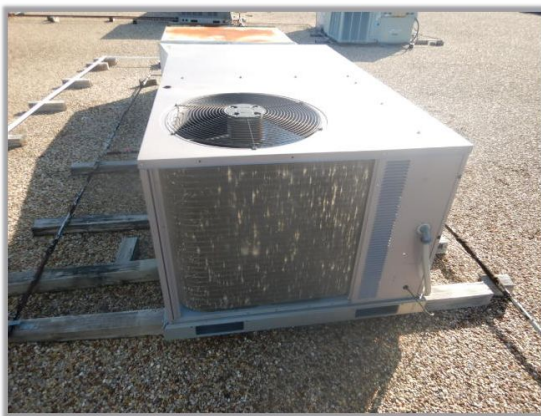
Unit #3

Hail Damaged fins. Recommend repair.

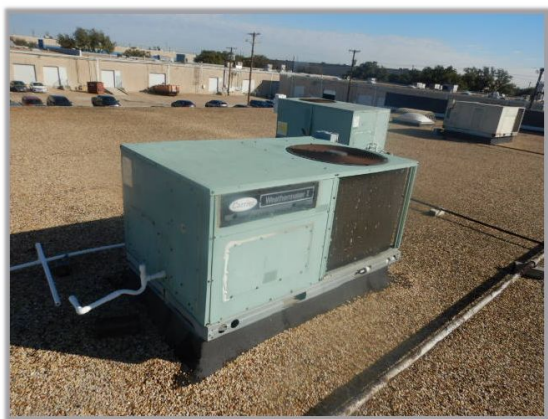
Disconnected condensate drain. Recommend repair.

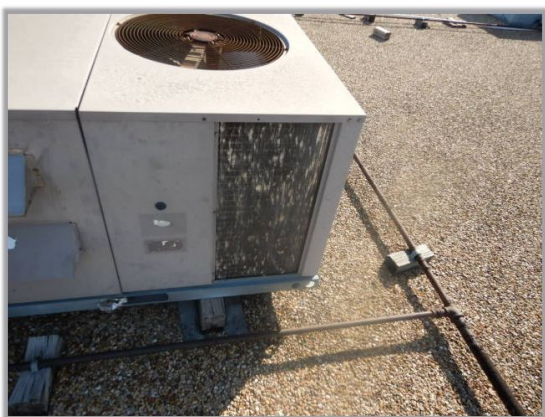
Hail Damaged fins. Recommend repair.

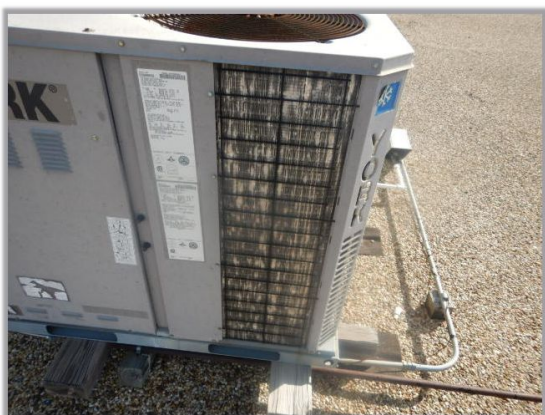
Hail Damaged fins. Recommend repair.

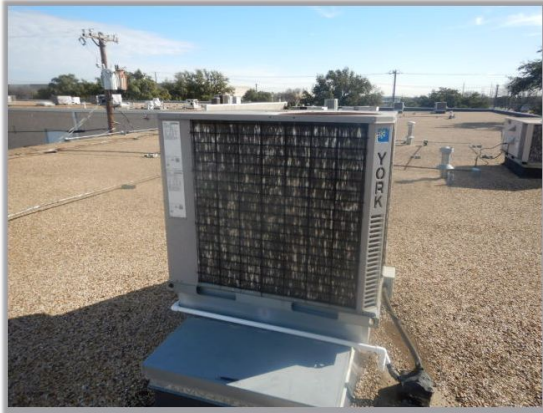
Hail Damaged fins. Recommend repair.

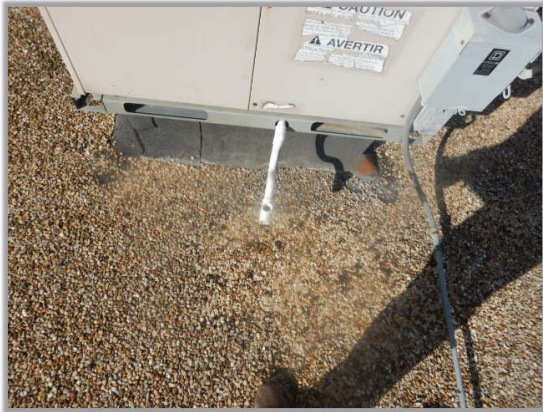
Disconnected condensate drain. Recommend repair.

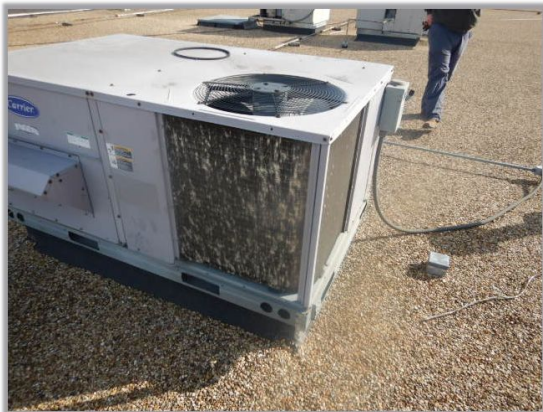
Hail Damaged fins. Recommend repair.

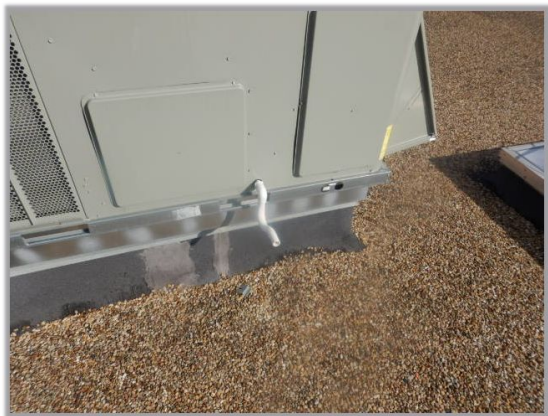
Condensate drain disconnected. Recommend repair.

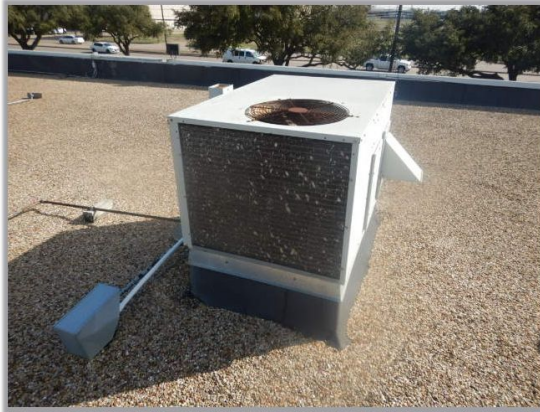
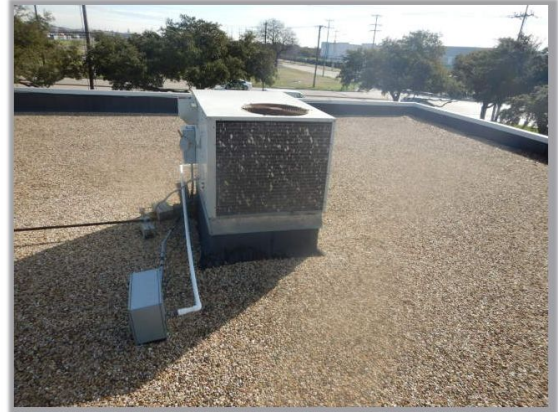
Disconnected condensate drain. Recommend repair.

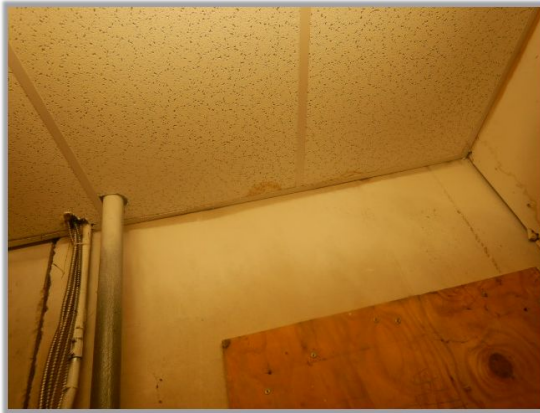
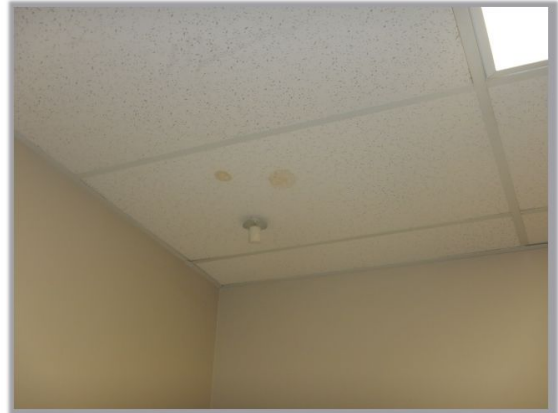
Ceiling Water staining was noted-- Electrical Closet and the west hallway . The cause of the water damage should be determined and Repairs undertaken if necessary to prevent further damage to the structure.

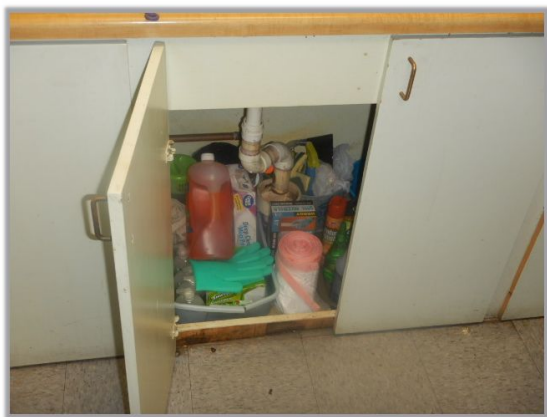
Improper drain connection at the kitchen sink. Ideally, repairs should be made.

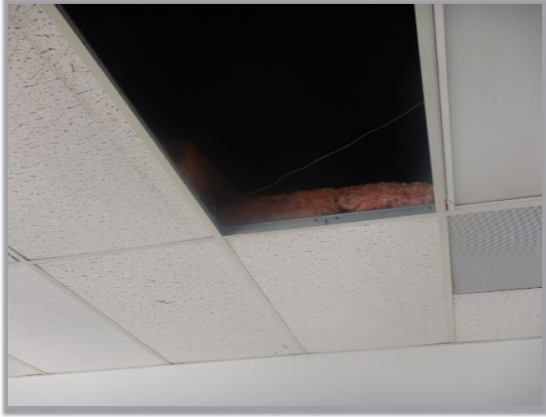
Missing ceiling tiles at many locations. Unit is being remodeled.

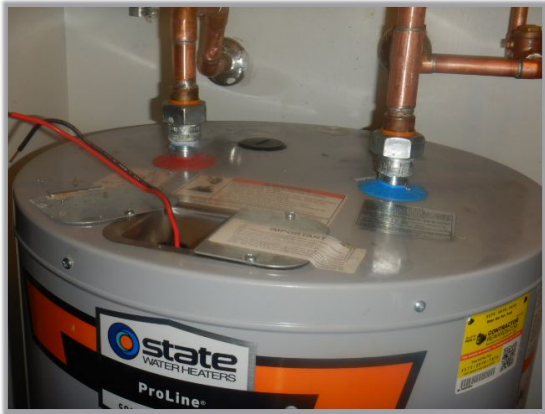
The unit is not connected to power. Recommend repair.

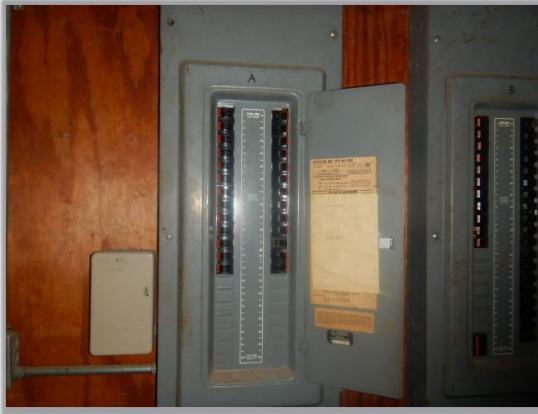
The structure is being served by an older “Federal Pacific” panel box. Due to the age of the panel box and the problems associated with these types of panel boxes, it is recommended that the owner of the structure consider upgrading this panel box with a more current panel box.

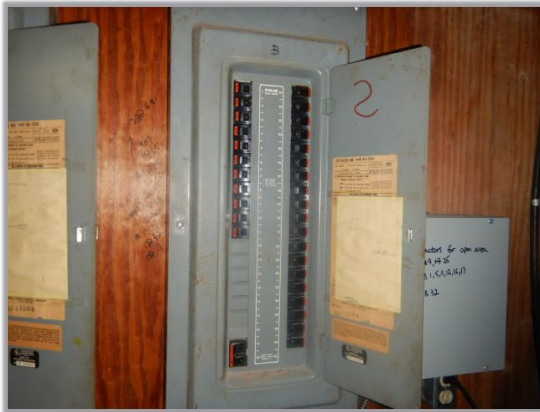
The structure is being served by an older “Federal Pacific” panel box. Due to the age of the panel box and the problems associated with these types of panel boxes, it is recommended that the owner of the structure consider upgrading this panel box with a more current panel box.

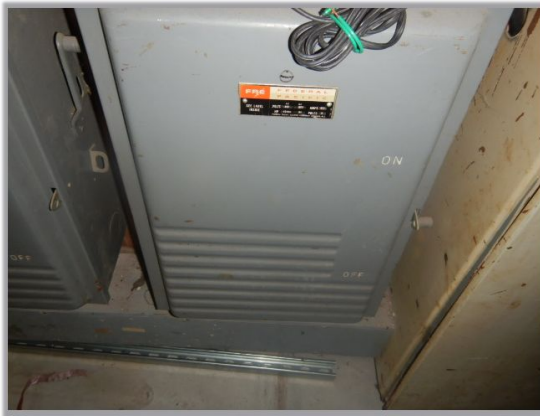
The Panel box is not connected to power.

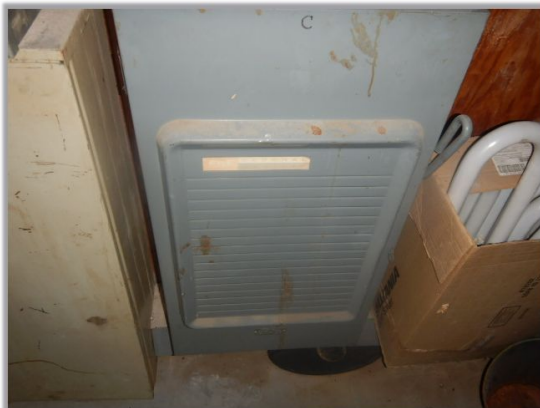
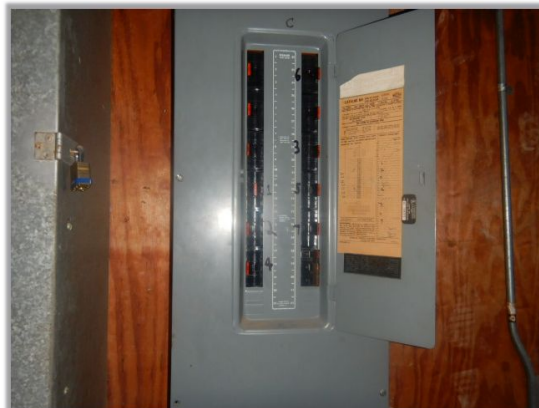
C

The structure is being served by an older “Federal Pacific” panel box. Due to the age of the panel box and the problems associated with these types of panel boxes, it is recommended that the owner of the structure consider upgrading this panel box with a more current panel box.

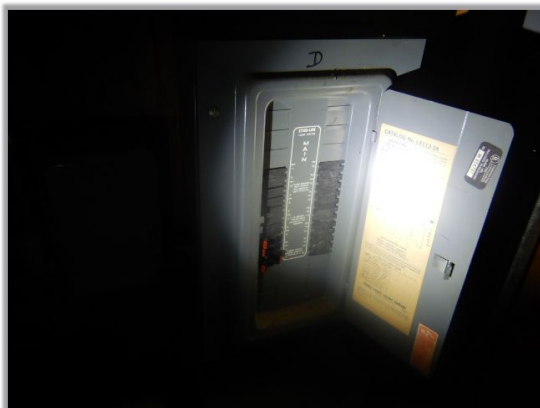
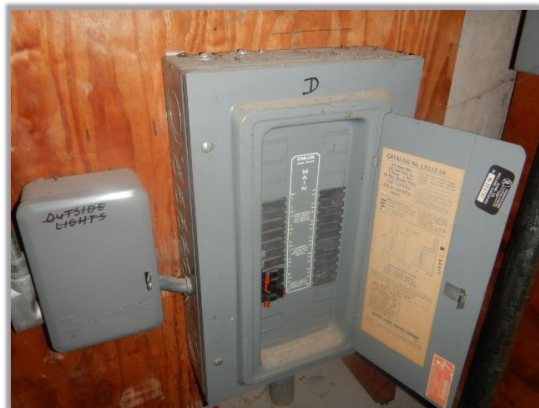
D

The structure is being served by an older “Federal Pacific” panel box. Due to the age of the panel box and the problems associated with these types of panel boxes, it is recommended that the owner of the structure consider upgrading this panel box with a more current panel box.

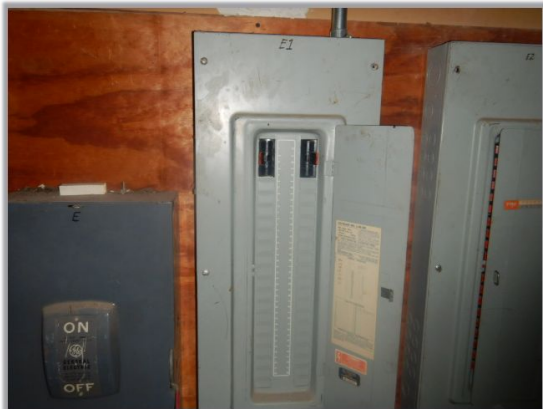
E1

The structure is being served by an older “Federal Pacific” panel box. Due to the age of the panel box and the problems associated with these types of panel boxes, it is recommended that the owner of the structure consider upgrading this panel box with a more current panel box.

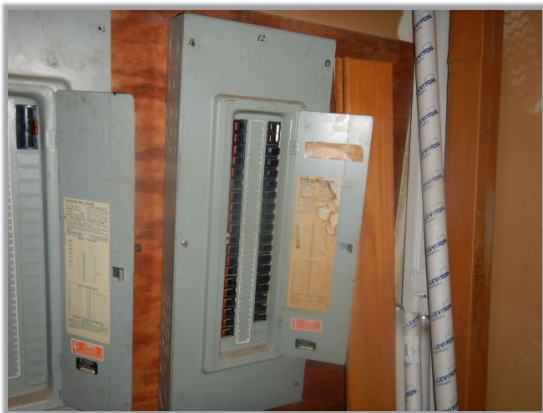
E2

The structure is being served by an older “Federal Pacific” panel box. Due to the age of the panel box and the problems associated with these types of panel boxes, it is recommended that the owner of the structure consider upgrading this panel box with a more current panel box.

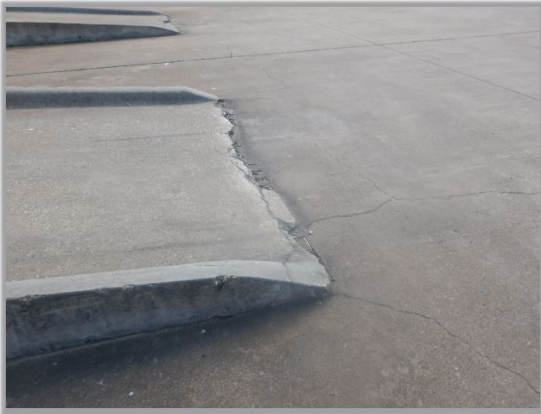
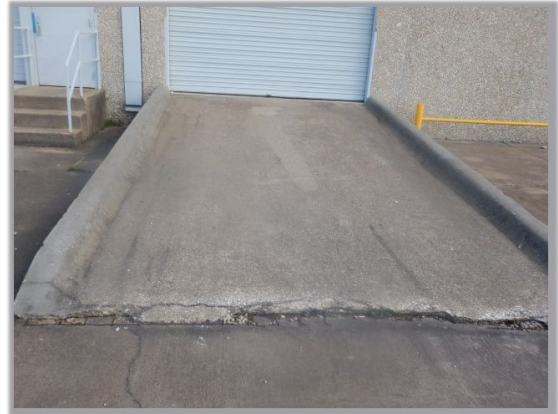
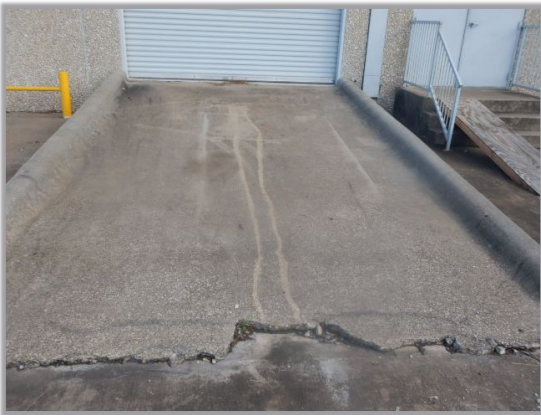
Minor damage to the loading dock ramps. Recommend monitoring for possible future repairs.

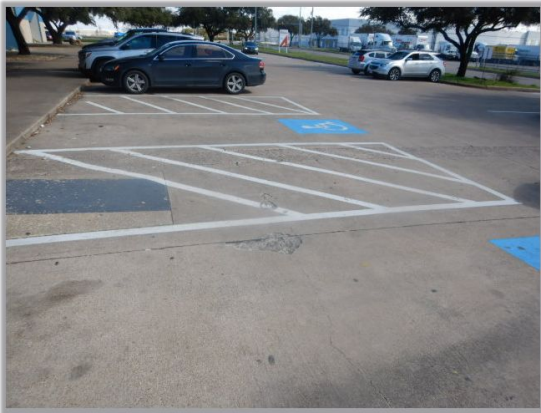
Considerable spalling of the concrete surface. Recommend repair.

Recommend repairs to the spalling concrete. Approximate cost \$2500

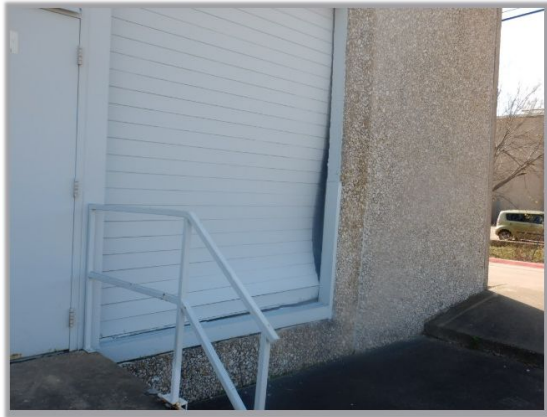
Minor damage to the garage door at unit 1137. Recommend repair or replacement as needed.
