PROPERTY INSPECTION REPORT

Concerning: 1234 Main Street, Dallas, TX 75223
(Address or Other Identification of Inspected Property)

By: Don Stafford, Lic #737 02/26/2020
(Name and License Number of Inspector) (Date)

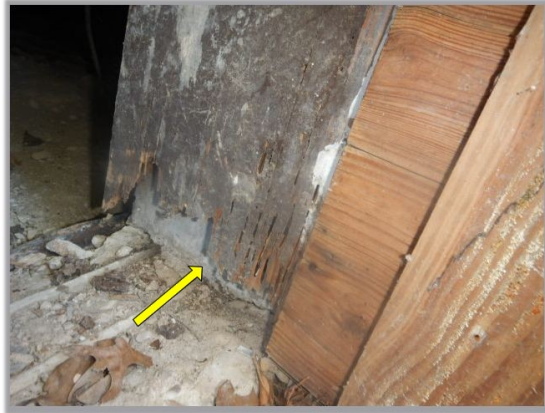
Minor wood rot at the trim at the exterior entry. Recommend replacement.

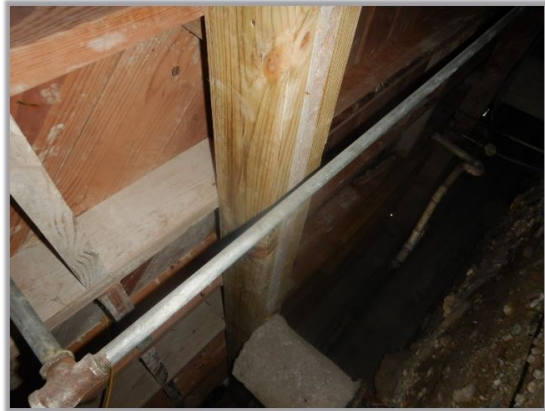
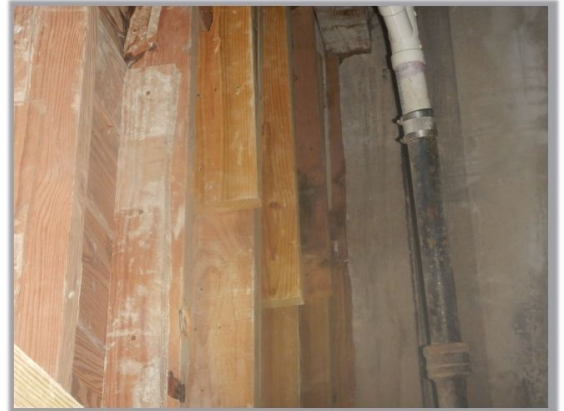
Evidence of previous repairs to the foundation-- Under the hall bathroom. Recommend contacting the current owner of the property for documentation as to scope of repairs and any warranty information that may be transferable.

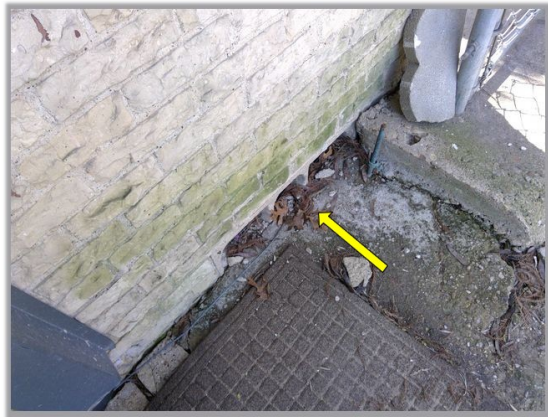
Some of the foundation vents are below grade at the rear of the structure. Foundation vents below grade allow water penetration into the crawlspace. Recommend regrading or as a minimum sealing these vents to help prevent water penetration into the crawlspace.

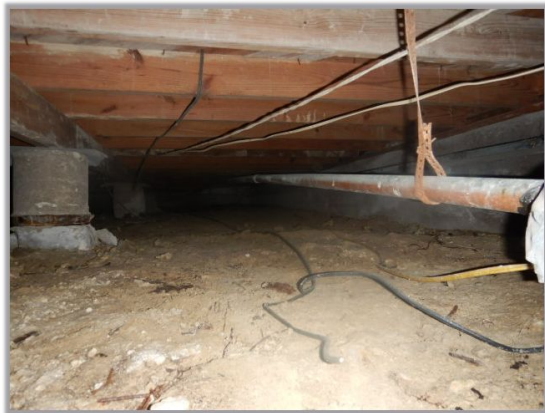
Some evidence of significant previous water penetration into the crawlspace-- West side/at the rear of the structure. Recommend further examination and repair as needed to prevent or minimize water penetration into the crawlspace.

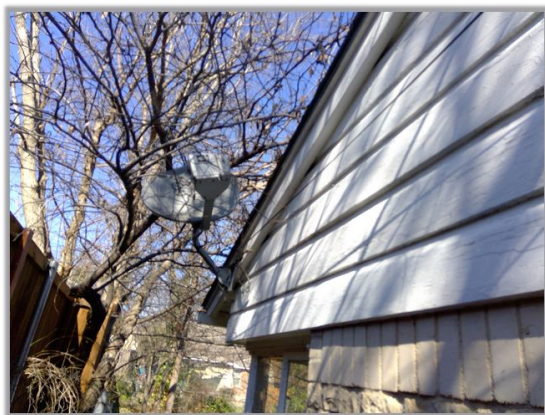
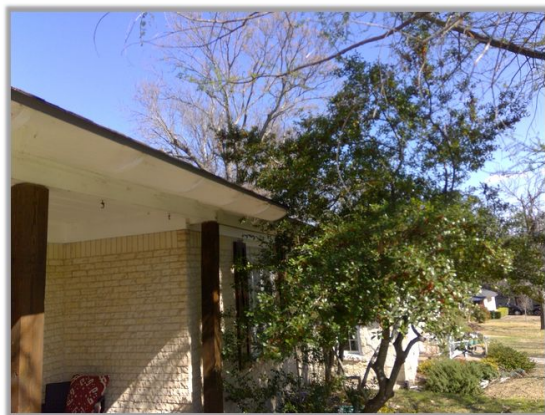
Maintenance: The Tree Limbs should be trimmed away from the roof surface--Various Locations. Tree Limbs should be trimmed to approximately 2' above the roof surface.

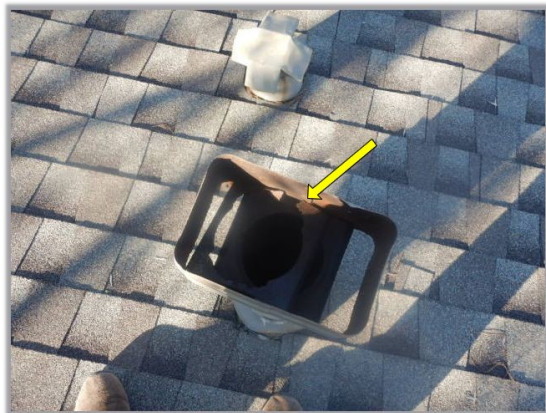
Damaged vent pipe at the rear roof. Recommend replacement.

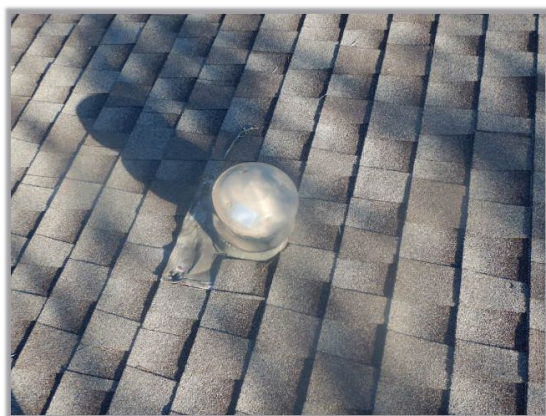
The furnace vent does not extend high enough above the roof surface. Recommend repair.

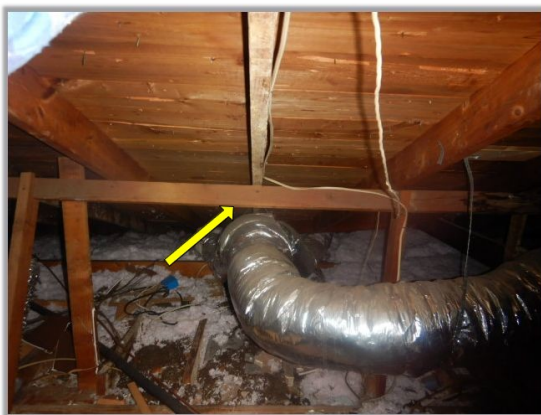
The purlin supports are undersized for current building practices. Recommend resupport if any sagging or weakness is noted.

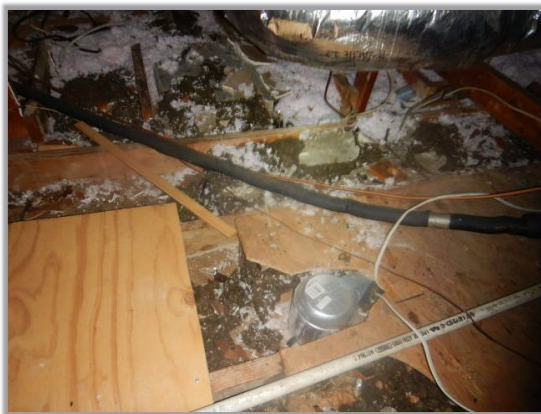
There is evidence of vermin/rodent activity in the attic. A pest control specialist should be called prior to closing. The insulation may be fouled due to rodents and have to be removed and replaced.

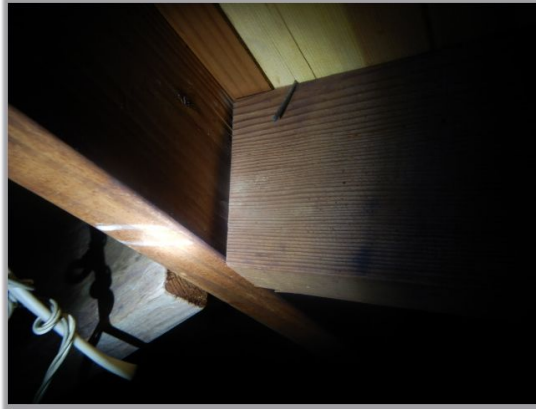
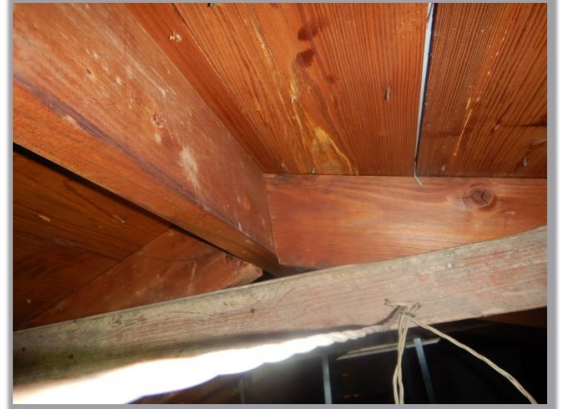
The cut end of the rafter extends below the ridge board. Current building standards require that full bearing be on the ridge board. No signs of significant structural movement or sagging. Recommend Monitoring for possible future repairs if any sagging occurs.

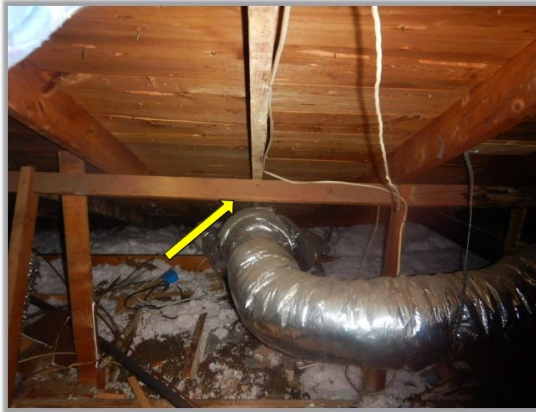
Some missing purlin supports-- Various Locations. Although this does not appear to have caused any structural defects or sagging the area should be monitored for possible future repairs.

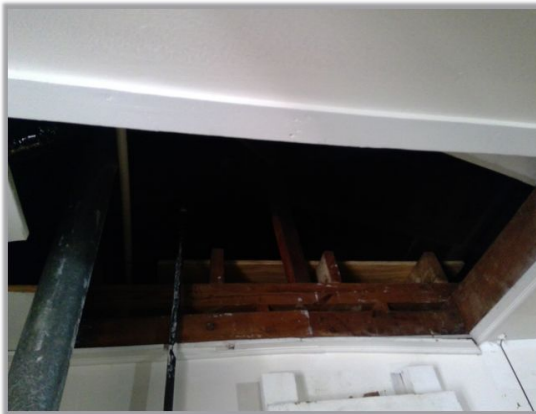
The attic access cover is missing/doesn't cover completely/damaged Garage attic. Recommend installing/replacing this cover.

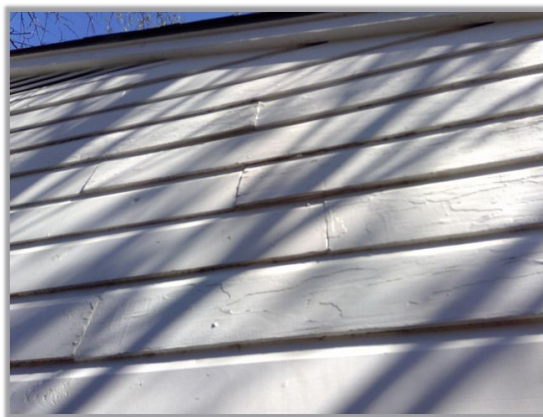
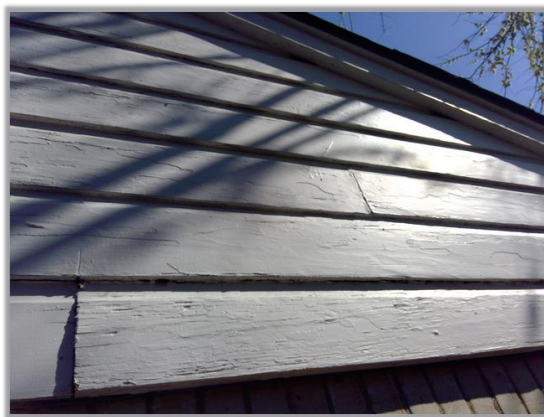
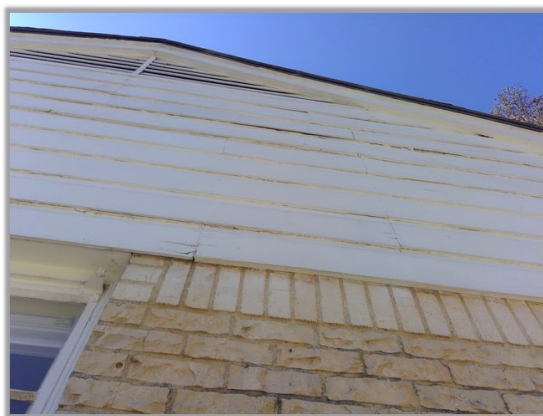
Minor flaking exterior paint-- Various Locations. The effected areas should be scraped, primed and repainted to protect the wood/siding/trim. Possible Lead base paint hazard on structures built before 1978. If Lead base paint is present, Additional repairs and lead safe practices will be required prior to repainting.

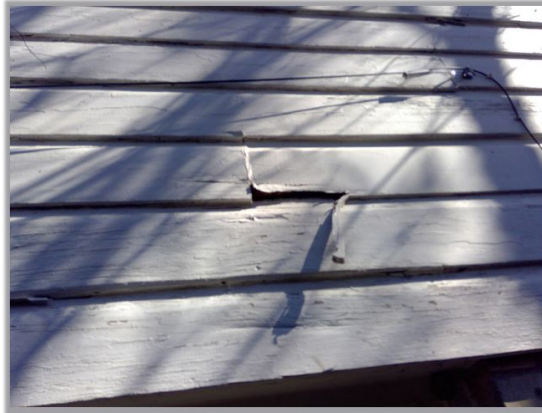
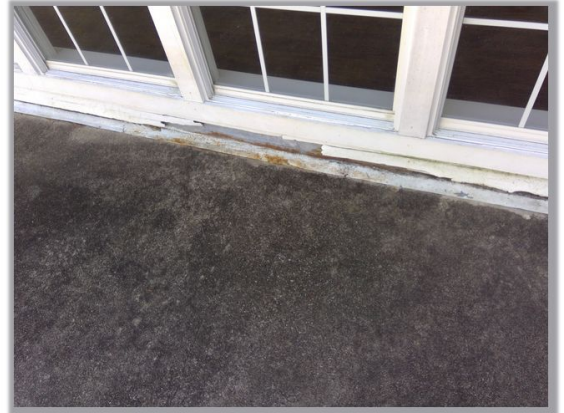
There is some damaged siding- at Various Locations Recommend repairs to prevent water penetration and damage to the structure.

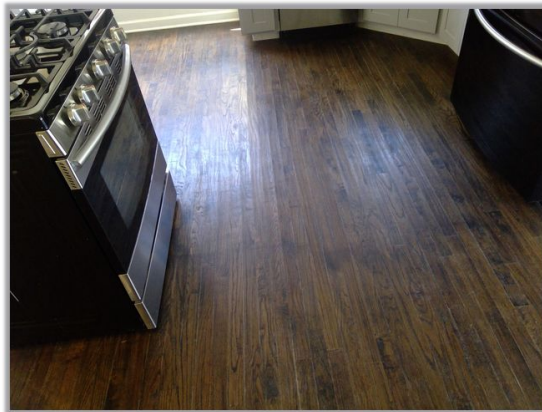
Some of the wood flooring is cupped at various locations. This can be an indication of excessive moisture or poor installation techniques. Recommend further examination to determine the exact causes and any remedies available.

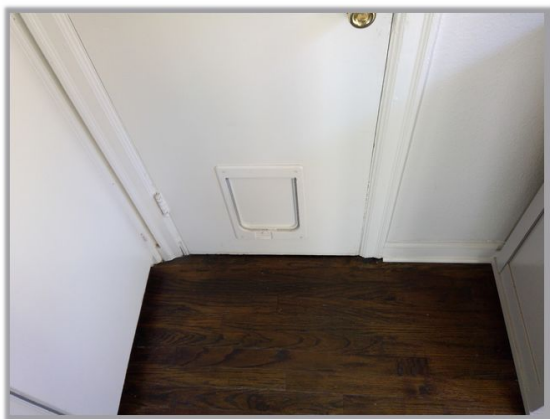
Ideally, the door between the garage and the living space should not be penetrated by a pet door or window. This removes the fire separation of the door. Recommend replacing the door with a fire rated door.

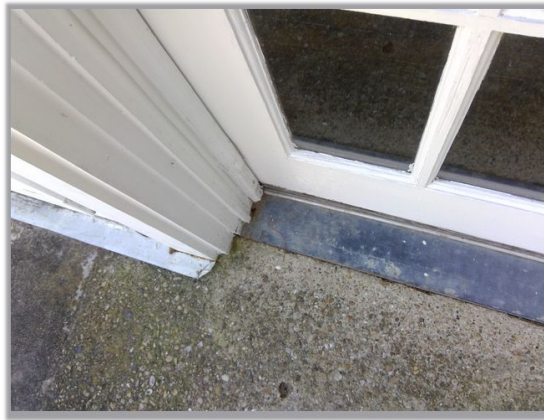
Damaged door jamb/trim Rear entry. Recommend repairs as needed.

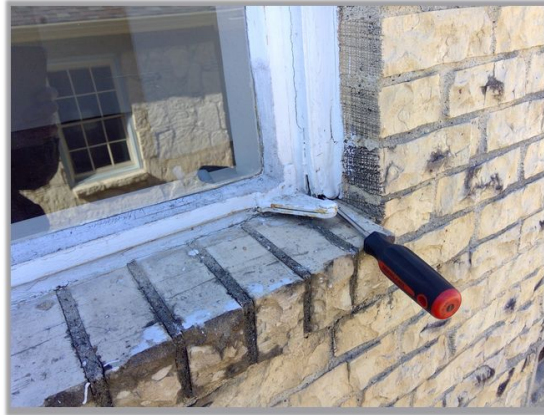
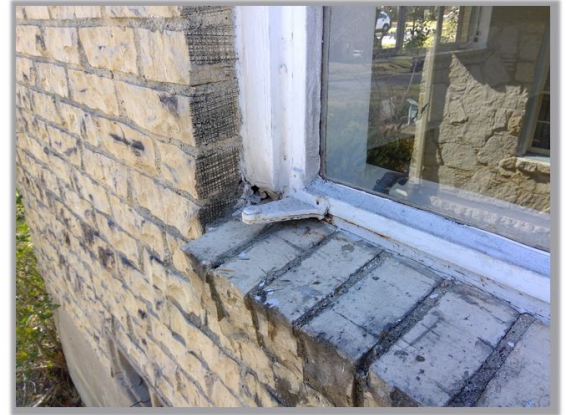
The window trim is damaged-- East side. Recommend repairs to prevent water penetration and damage to the structure.

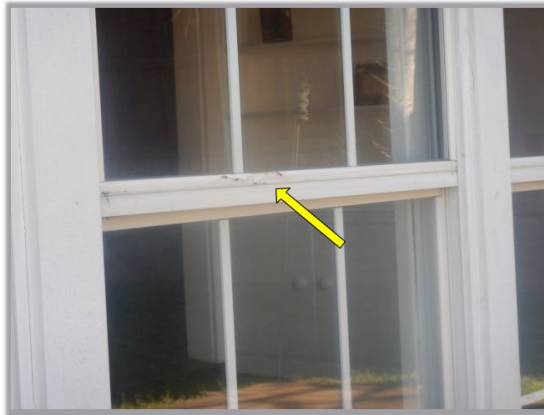
Damaged window plastic glazing strips-- Rear addition. The window plastic glazing strips help weatherproof the window(s). Recommend replacement of the plastic glazing strips to maintain the weather proofing of the windows.

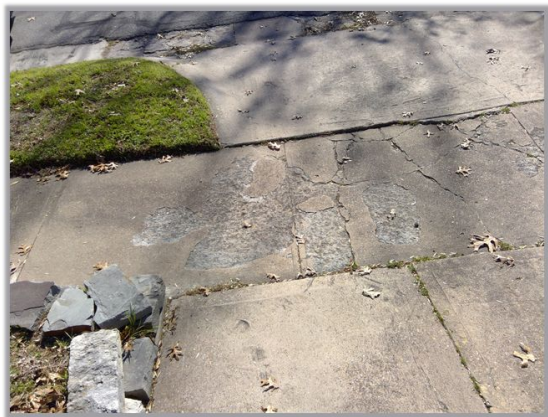
The sidewalk is somewhat settled/damaged at the parkway, Recommend repair or replacement.

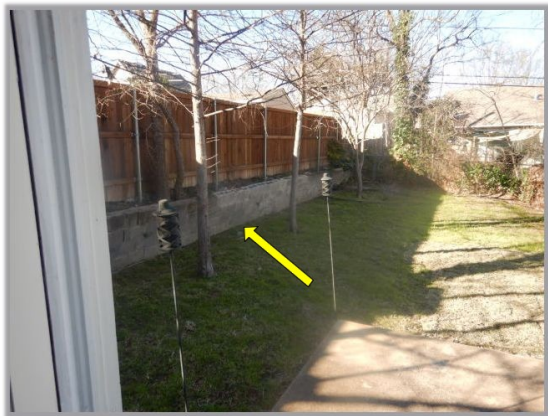
The retaining wall at the West side of the back yard is in poor condition. Recommend replacement.

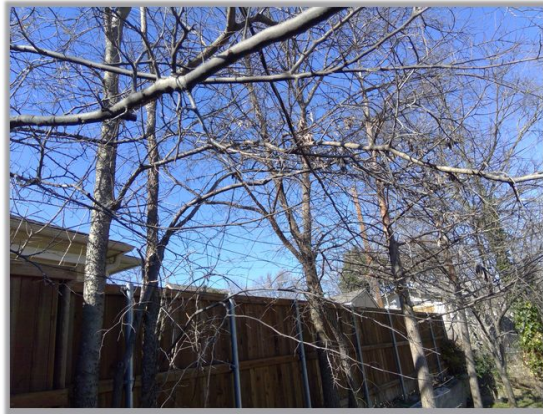
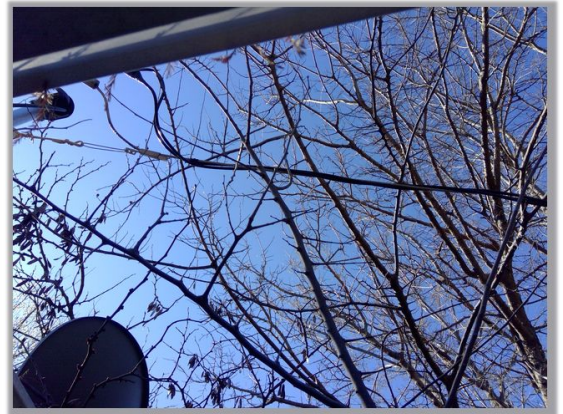
The main entry wires are rubbing on a tree/branch at the rear of the structure. Recommend contacting the Electric Service provider to relocate the wire or an arborist to trim the tree/branches to prevent damage to the wire.

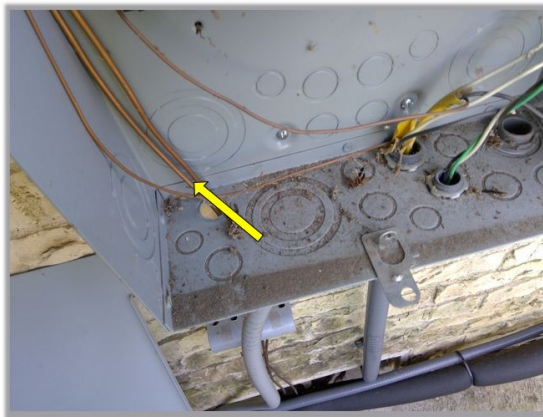
The ground electrode conductor is somewhat too small. Recommend further evaluation and repair as needed.

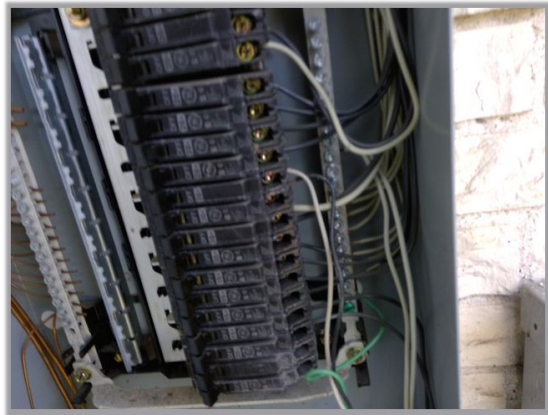
Wiring in the panel box(es) is not properly identified. Some white insulated wires are being used as ungrounded "hot" circuits. Ideally, the wiring should be properly identified with appropriately permanent markings, (electricians tape or other means). Recommend repair.

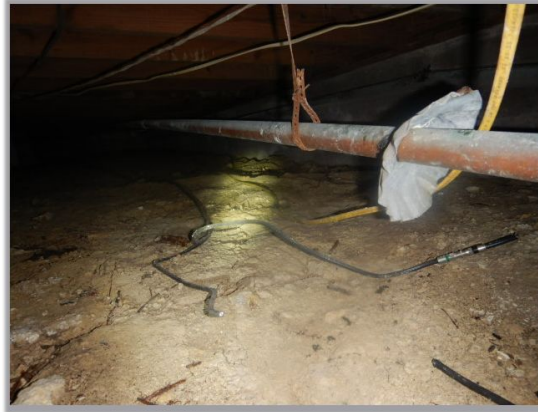
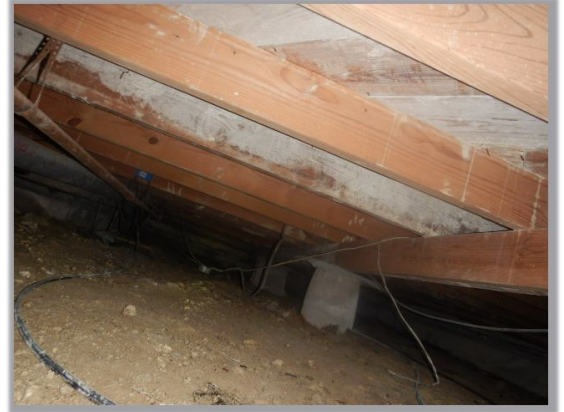
Some wiring is present on the ground in the crawlspace--various locations . Recommend securing the wire to the substructure to prevent damage to the wire and for safety reasons.

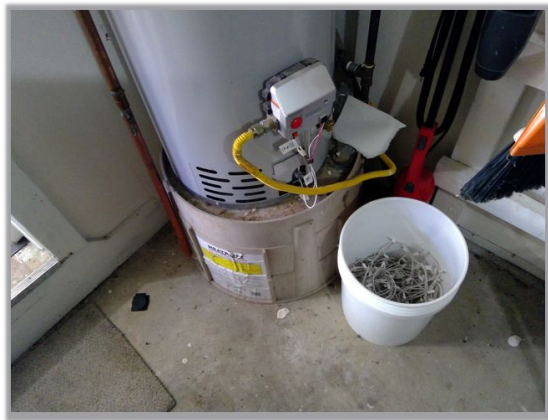
The discharge piping serving the emergency drain pan for the water heater does not terminate outside. The drain should terminate at the exterior of the house or in an approved location.

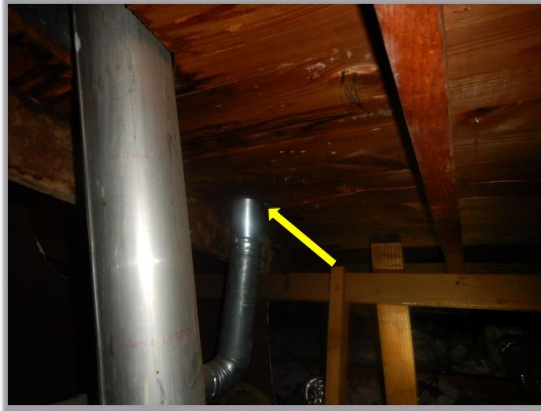
The vent pipe serving the water heater does not have safe clearance from combustibles--attic. Recommend Repair.

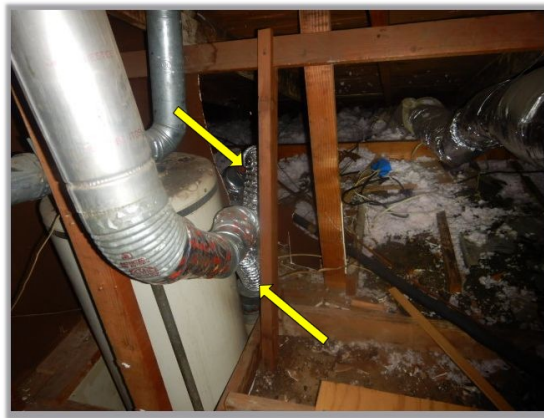
The material used for the range hood venting is improper. Recommend further examination and repair as needed.

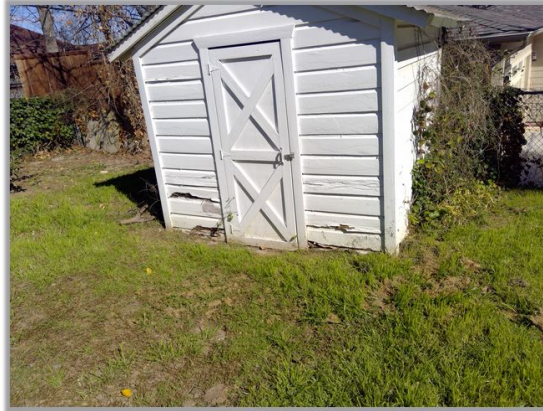
The detached storage shed is in poor condition. Not inspected.
