Property Condition Assessment

Report Date: October 14, 2019

Property Address: 1234 Main Street
Cedar Hill, TX 75104

Prepared By: Stafford Inspections
2328 Southwood Dr.
Dallas, TX 75224

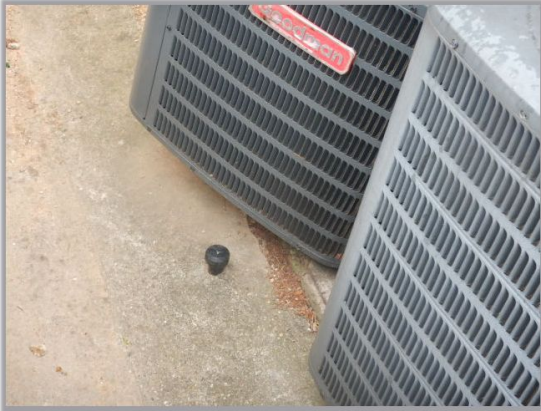
Many of the units are not sitting squarely on the concrete pads. Some of the pads are too small for the unit. Ideally, the unit pads should be replaced when replacing the units.

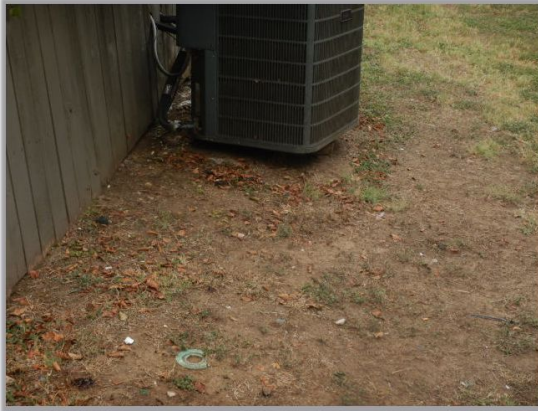
Missing/Damaged insulation on refrigerant lines --at Many Locations. Recommend repair or replacement.

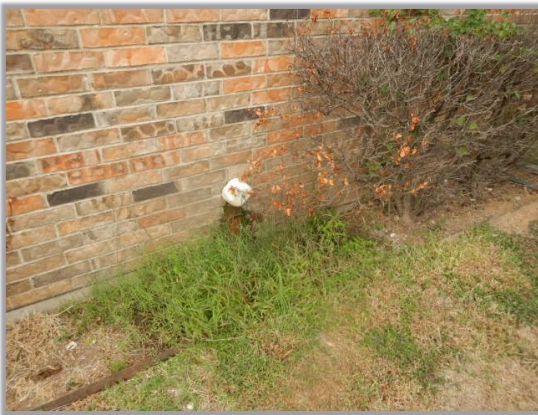
Supply Piping
Hose bibs are leaking at Building C , D and E. Recommend repair or replacement as needed.

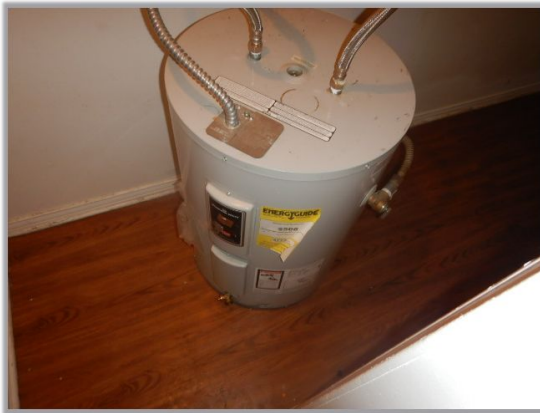
The water heater does not have a safety pan. Recommend installing a safety pan to prevent damage.

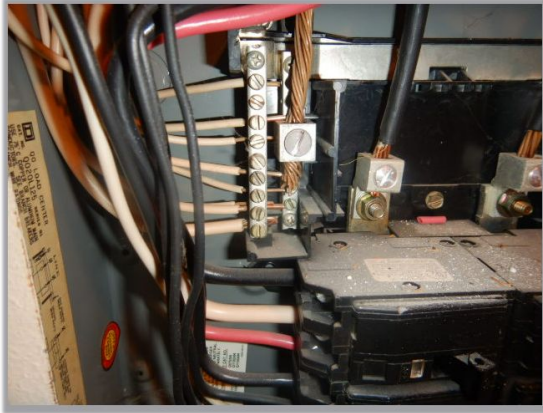
Multiple neutral wire connections were located under a single screw at the panel box. CURRENT building standards do not allow this type of electrical connection. Recommend further evaluation and repair as needed.

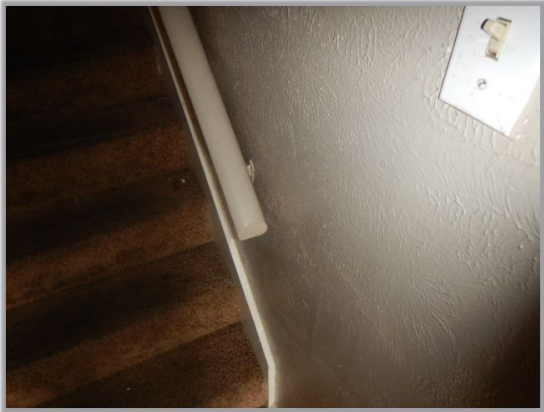
The stairway handrail should have a turnback at the top and bottom ends of the stairway handrail in order to meet current building standards. (Turnbacks are where the ends of the handrail turn back to the wall to prevent snagging.) Recommend Repair.

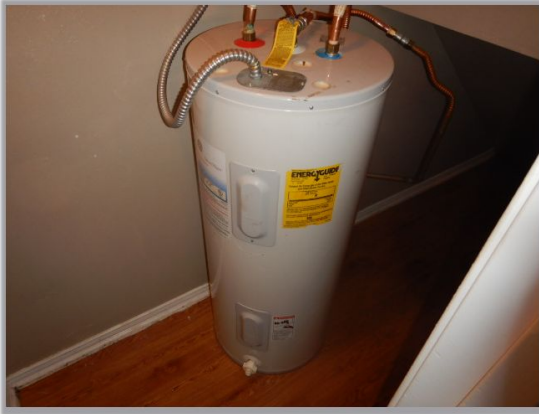
The water heater does not have a safety pan. Recommend installing a safety pan to prevent damage.

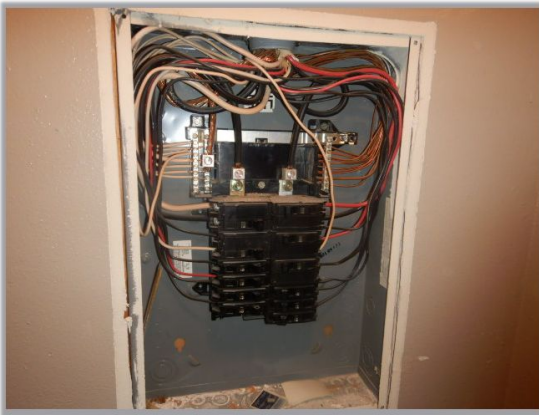
There is inadequate clearance at the front and sides of the panel box. Recommend relocating the panel box for increased safety and to conform to current building standards.

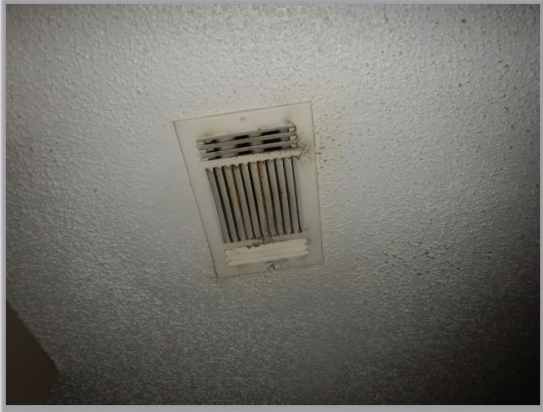
Dirty filter. Recommend replacing.

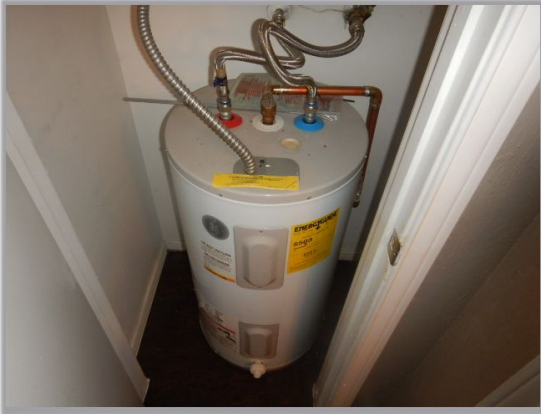
Water Heater Description and Location: Electric 240 volt 30 Gallons Bedroom closet 2012

The water heater does not have a safety pan. Recommend installing a safety pan to prevent damage.

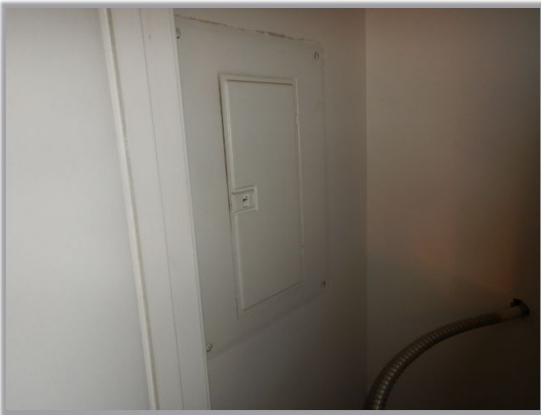
Box Location: 100 amps Hallway

The ground buss bar and the Neutral buss bar should be separated in the subpanel box(es). Neutral wires are not allowed to touch the ground buss bar in subpanel boxes. The ground bonding is through the main panel box not the subpanel box(es). Recommend further examination and repair as needed.

Wiring in the panel box(es) is not properly identified. Some white insulated wires are being used as ungrounded "hot" circuits. Ideally, the wiring should be properly identified with appropriately permanent markings, (electricians tape or other means). Recommend repair.

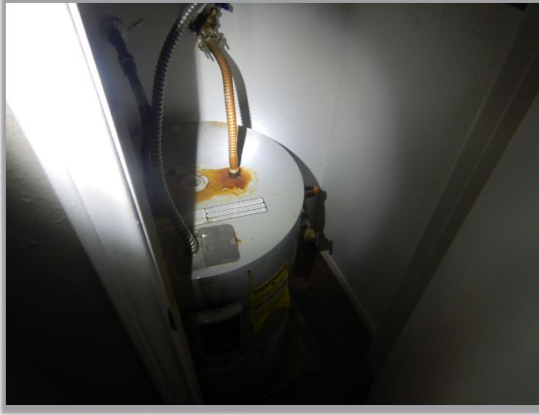
Water Heater Description and Location: Electric 240 volt (Being replaced. Leaking)

The water heater does not have a safety pan. Recommend installing a safety pan to prevent damage.

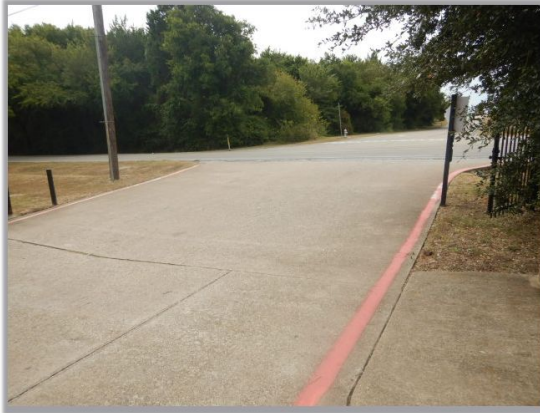
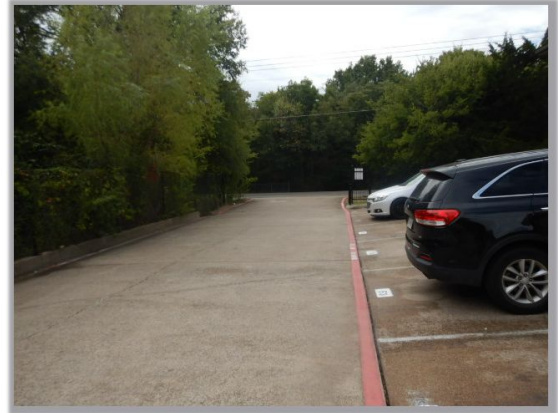
Parking, Driveway, Sidewalk(s) entries

Parking Places: 125

☐ Asphalt--☒ Concrete Driveway/Parking lot(s)
☒ Concrete- Sidewalks

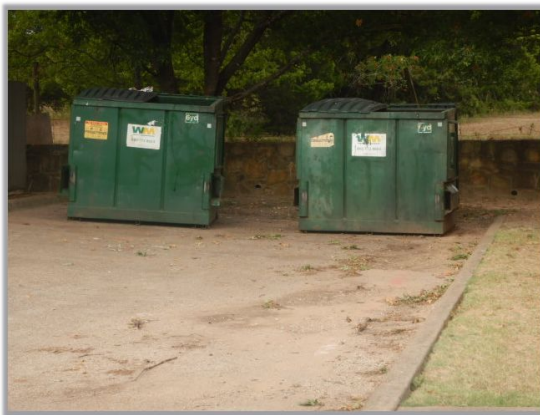
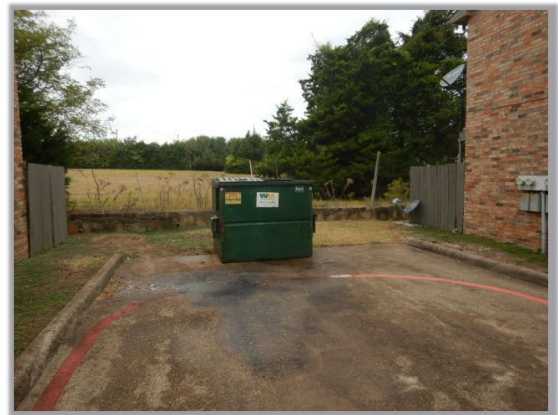
Trash Disposal

5 Bin(s)

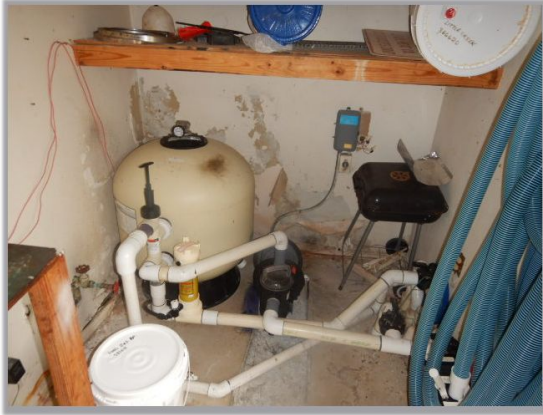
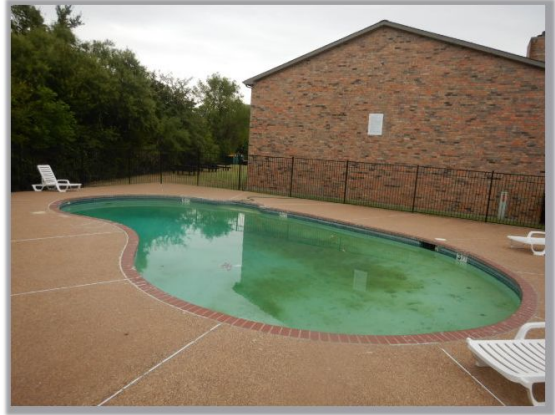
Construction type: Inground Gunite - Plaster surface Sand Filter

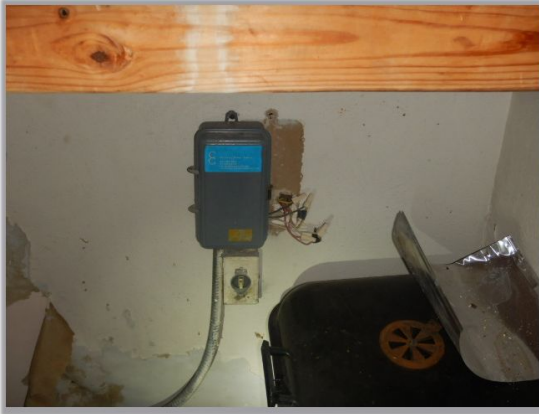
Damaged wiring at the timer for the pool filter. Recommend repair.
