Property Condition Assessment

Report Date: February 6, 2020

Property Address: 1234 Main Street
Garland, TX

Prepared By: Stafford Inspections
2328 Southwood Dr.
Dallas, TX 75224

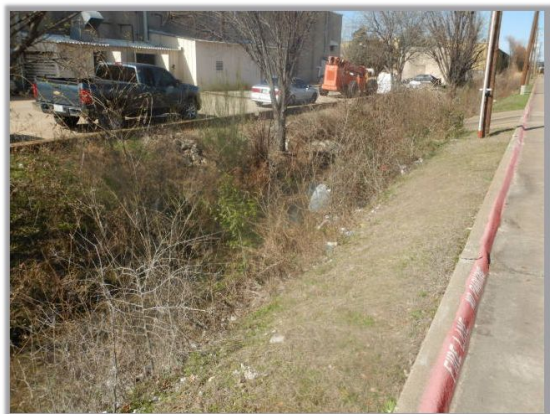
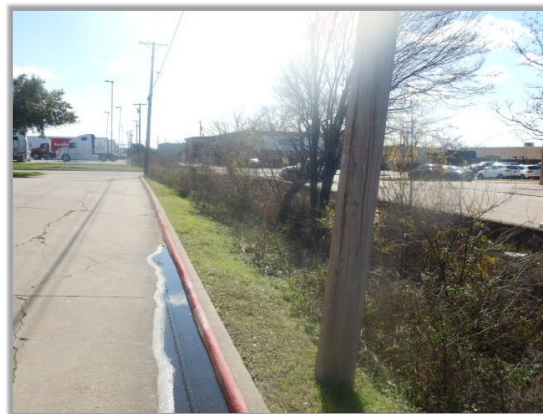
The general grading of the parking areas slopes to the East and West. The east drains to the City of Garland Storm sewer. The West drains to a storm drainage ditch.

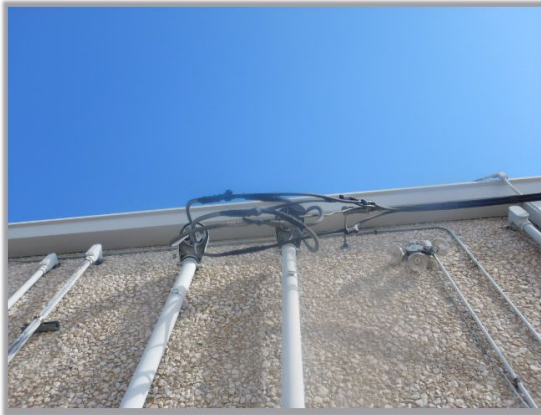
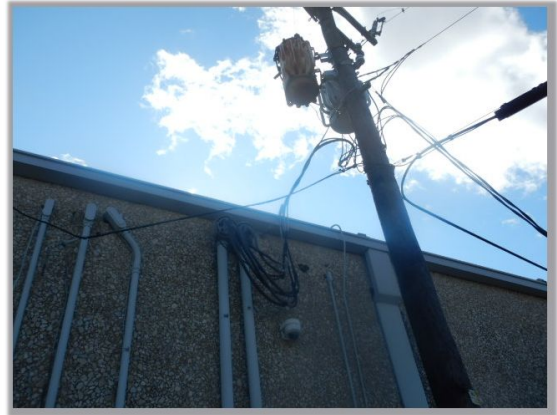
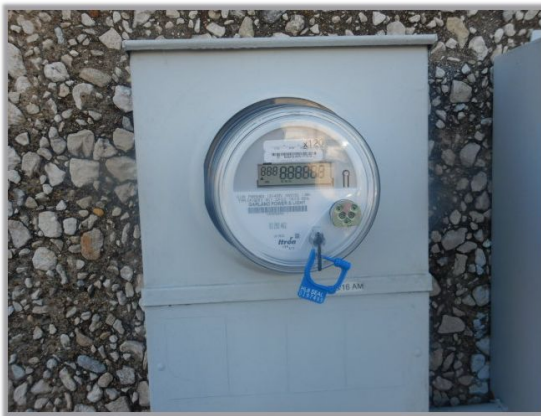
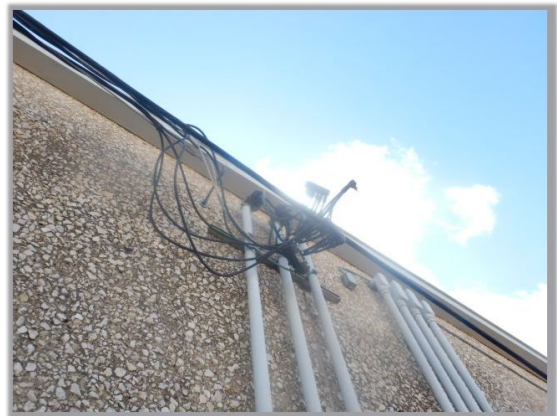
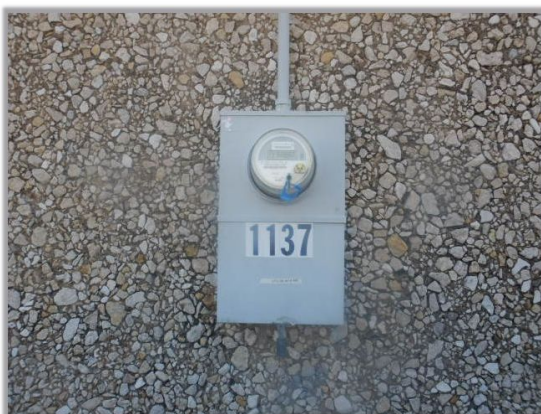
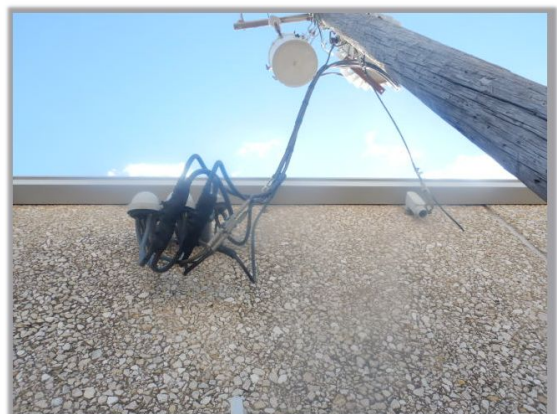
Service Entry Overhead , At the rear of the structure, 120/240 volt 3-phase

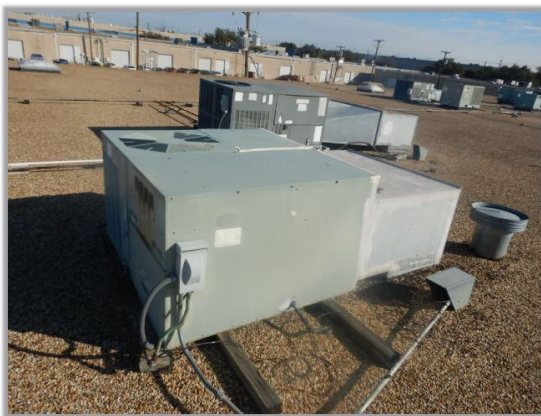
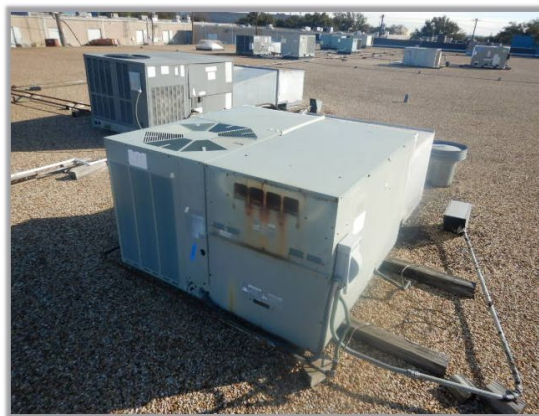
**Package unit with Electric AC and Gas furnace Unit #4 Rheem***Approximate Condenser Age: Missing Tag/Approximate age/1996/R/22 refrigerant**Approximate Condenser Size: No Tag/Approximate size/6 ton/8 ton*

(9) of the 22 units are older and at the end of their expected useful life. Recommend budgeting to replace the units as needed. Approximate cost \$15,000 per unit. (\$135,000)

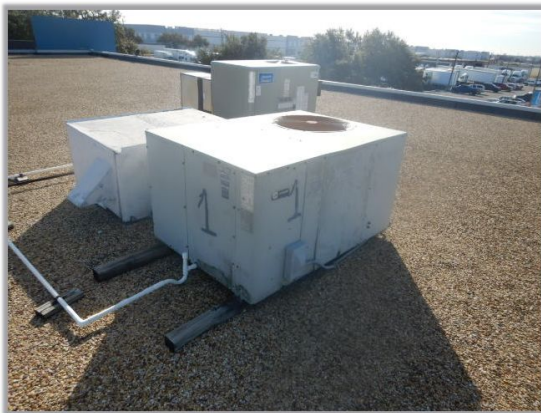
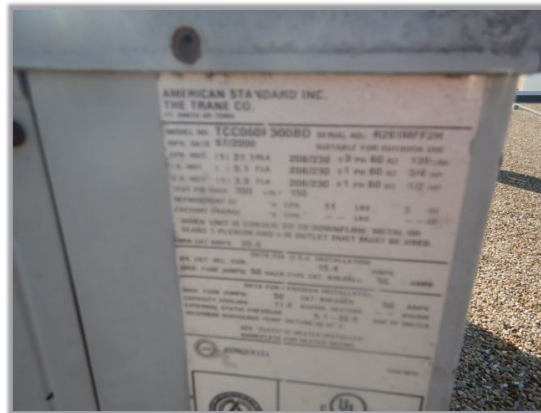
Package unit with Electric AC and Electric Furnace Unit #8 Trane

Approximate Condenser Age: 2000/R/22 refrigerant

Approximate Condenser Size: 6 ton/8 ton

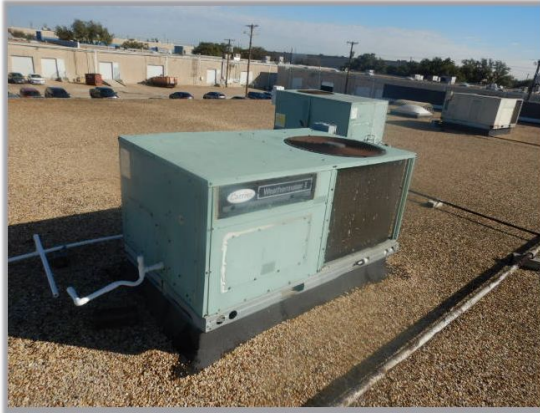
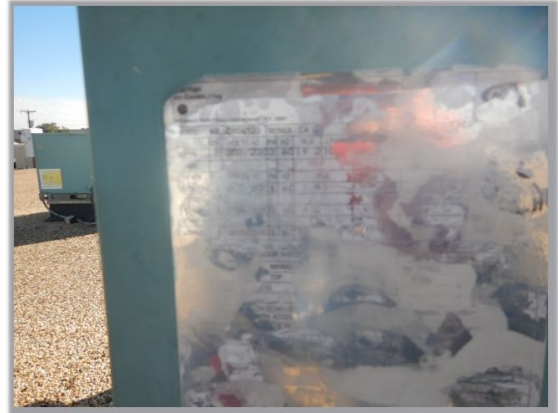
Package unit with Electric AC and Gas furnace Unit #10 Carrier

Approximate Condenser Age: Missing Tag/Approximate age/1990

Approximate Condenser Size: Missing Tag/Approximate size/4 ton

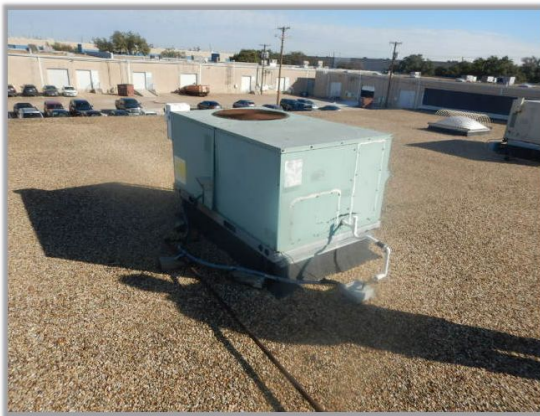
**Package unit with Electric AC and Gas furnace Unit #11 Trane**

Approximate Condenser Age: Missing Tag/Approximate age/1985/R/22 refrigerant

Approximate Condenser Size: Missing Tag/8 ton/10 ton

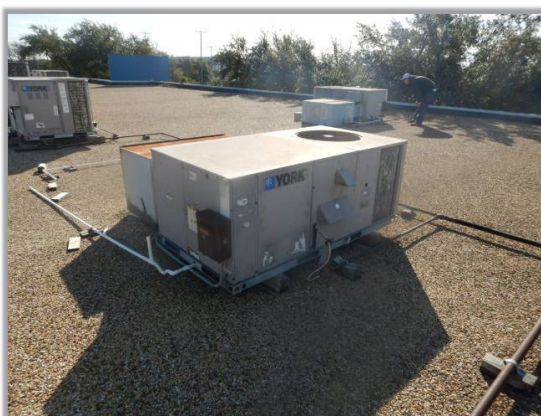
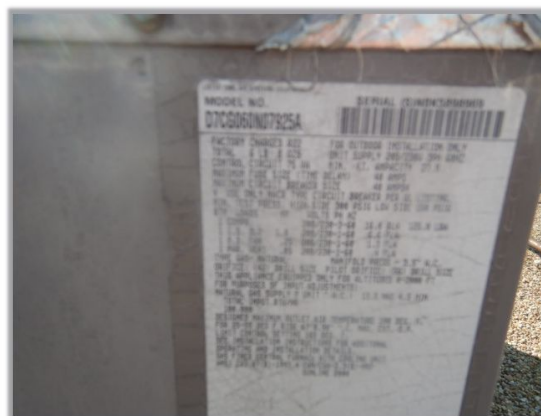
**Package unit with Electric AC and Gas furnace Unit #13 York***Approximate Condenser Age: 1998/R/22 refrigerant**Approximate Condenser Size: 5 ton*

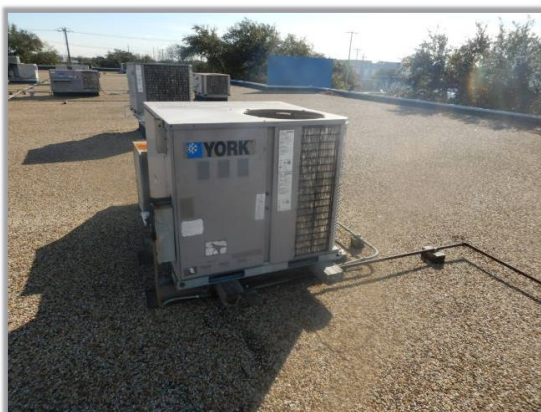
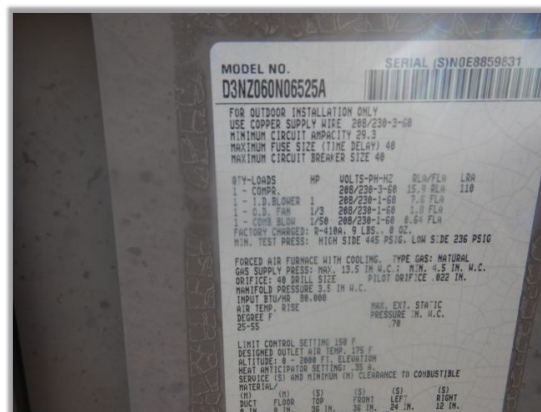
**Package unit with Electric AC and Gas furnace Unit #14 York***Approximate Condenser Age: R/22 refrigerant**Approximate Condenser Size: 5 ton*

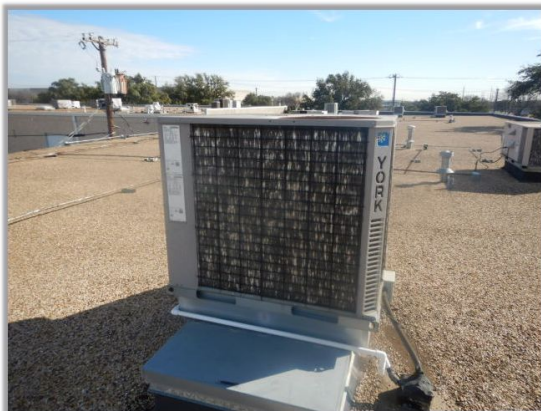
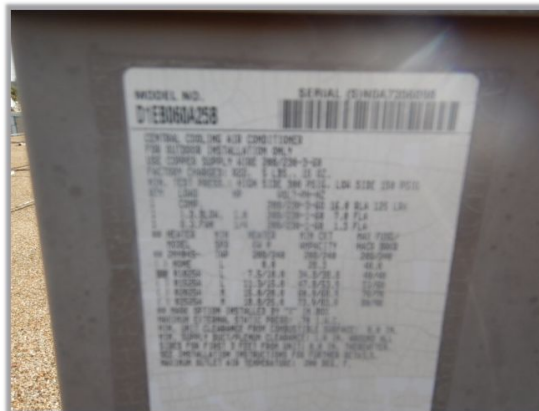
Package unit with Electric AC and Gas furnace Unit #15 York*Approximate Condenser Age: 1998/R/22 refrigerant**Approximate Condenser Size: 5 ton*

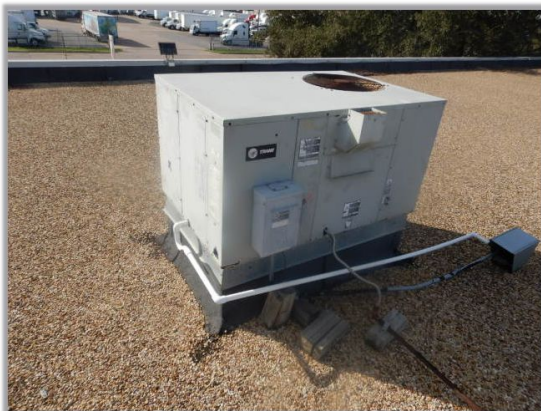
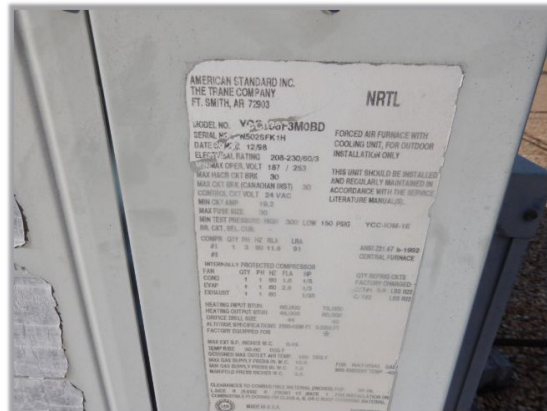
Package unit with Electric AC and Gas furnace Unit #22 Trane

Approximate Condenser Age: R/22 refrigerant

Approximate Condenser Size: 3 ton

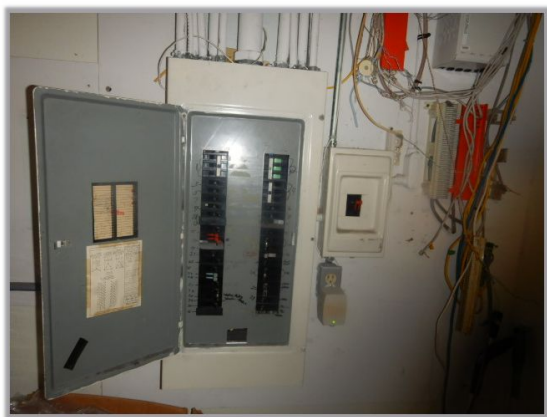
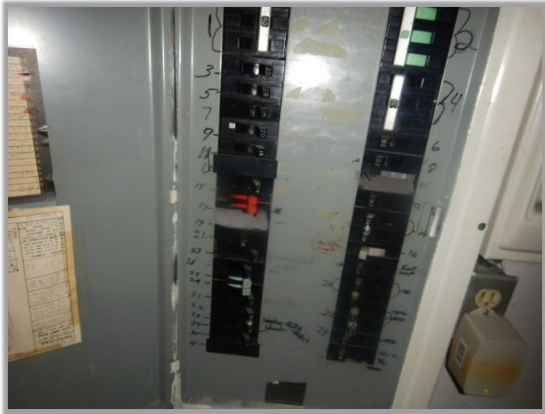
The panel box has openings present. Any openings in the panel box should be covered/filled.

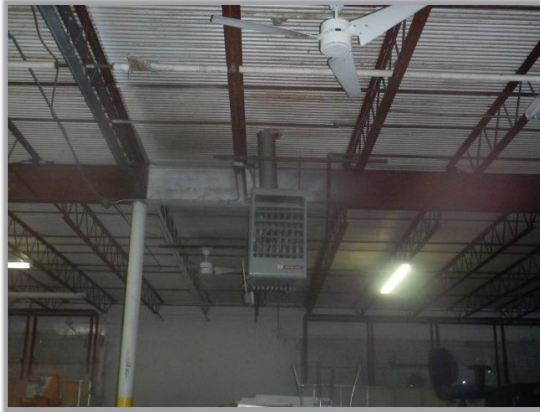
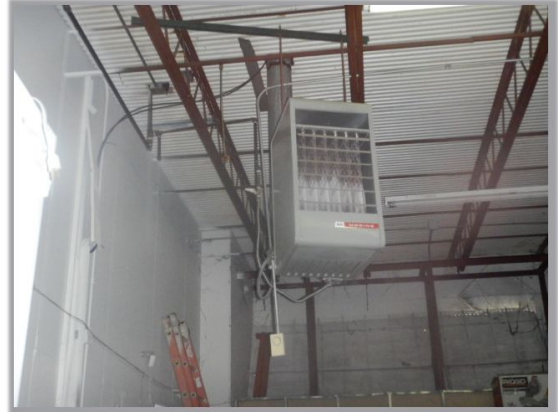
Open Bay Heaters (2)

The units are not being used.

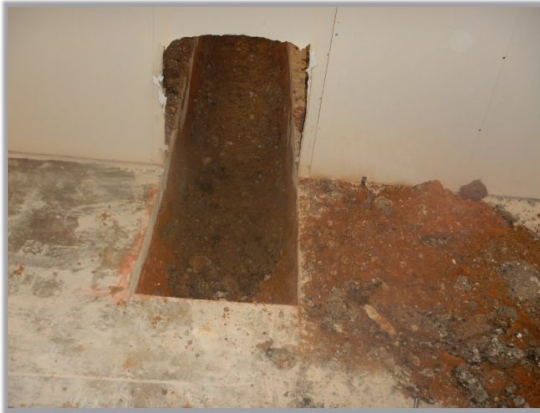
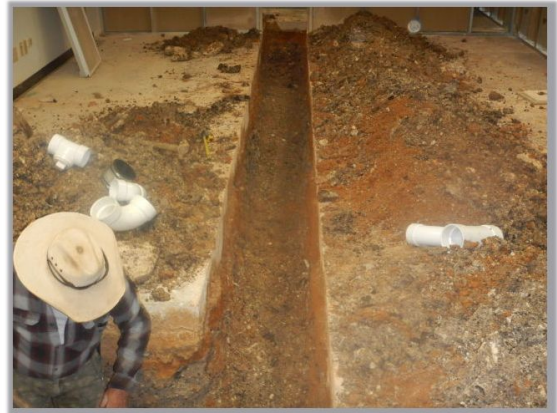
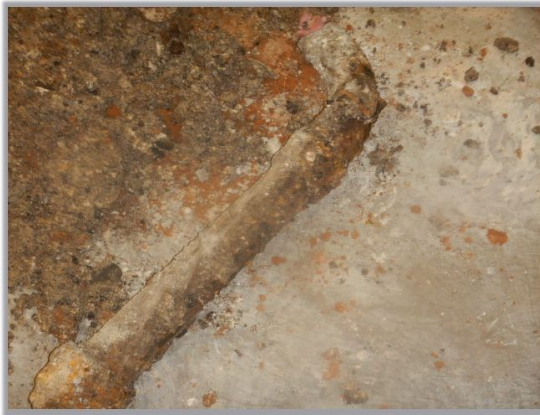
Plumbing Fixtures

The plumbing systems are being remodeled at the time of inspection.

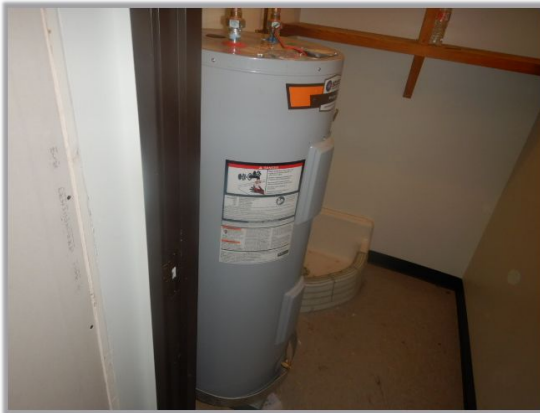
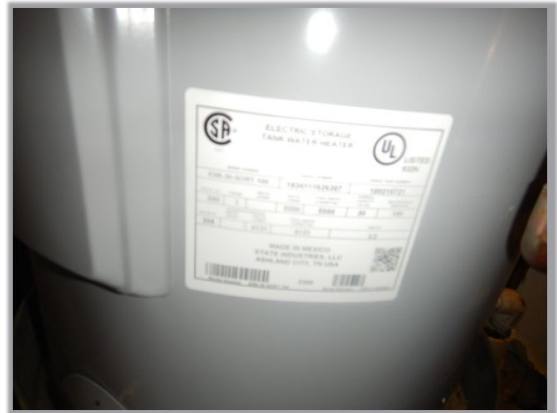
**Water Heater Description and Location: Electric 240 volt 30 Gallons Storage closet 2015**

The unit is not connected to power. Recommend repair.

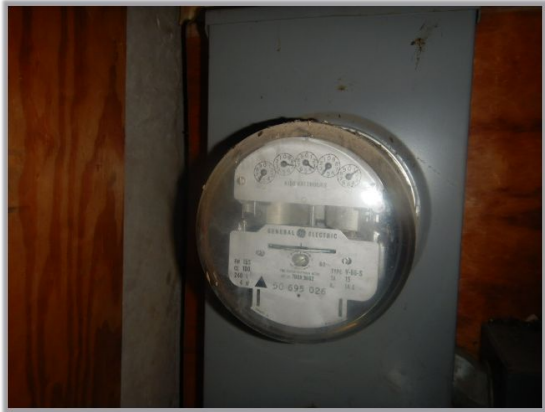
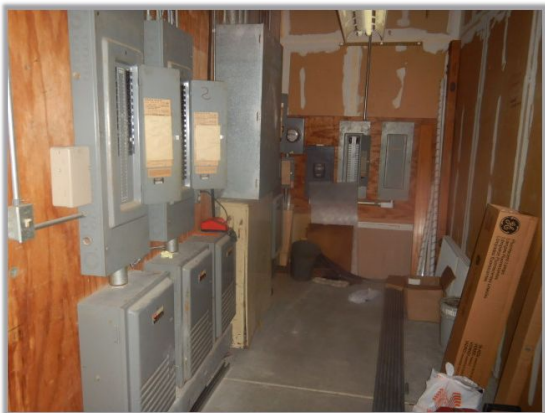
A

The structure is being served by an older “Federal Pacific” panel box. Due to the age of the panel box and the problems associated with these types of panel boxes, it is recommended that the owner of the structure consider upgrading this panel box with a more current panel box.

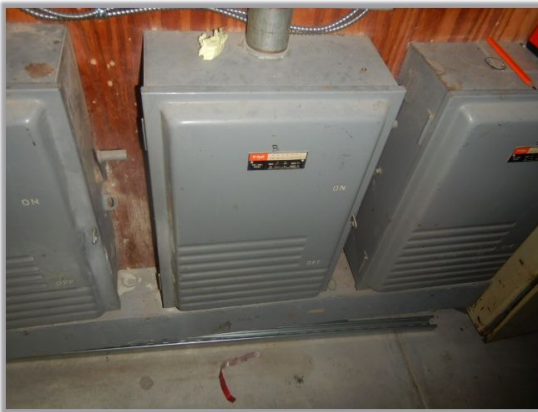
B

The structure is being served by an older “Federal Pacific” panel box. Due to the age of the panel box and the problems associated with these types of panel boxes, it is recommended that the owner of the structure consider upgrading this panel box with a more current panel box.

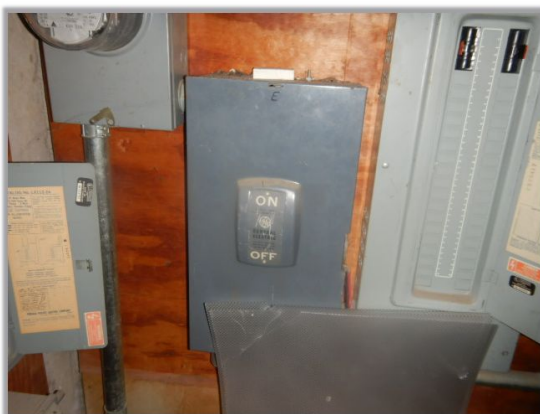
E1

The structure is being served by an older “Federal Pacific” panel box. Due to the age of the panel box and the problems associated with these types of panel boxes, it is recommended that the owner of the structure consider upgrading this panel box with a more current panel box.

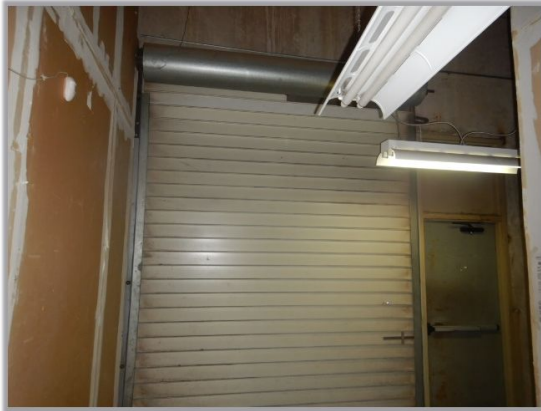
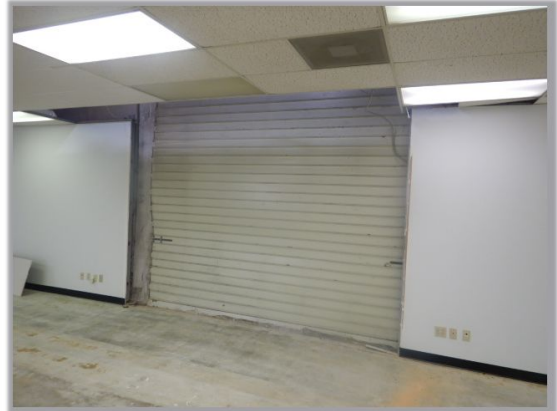
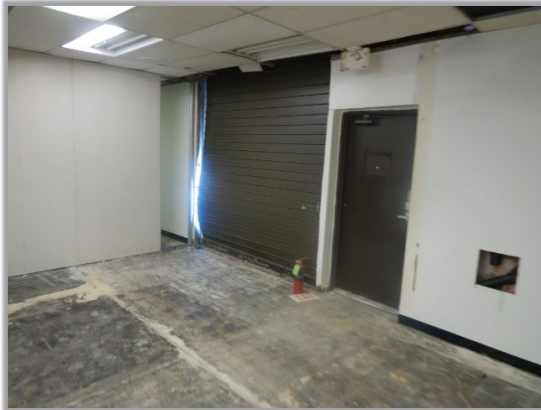
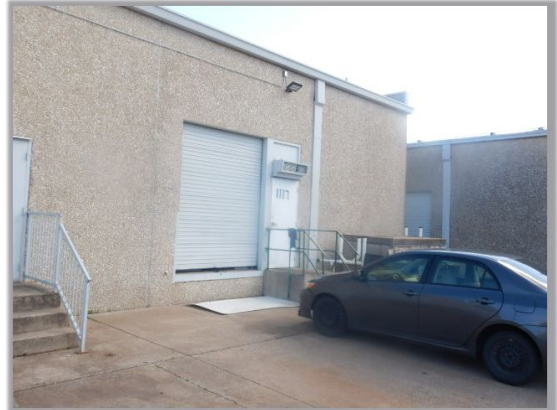
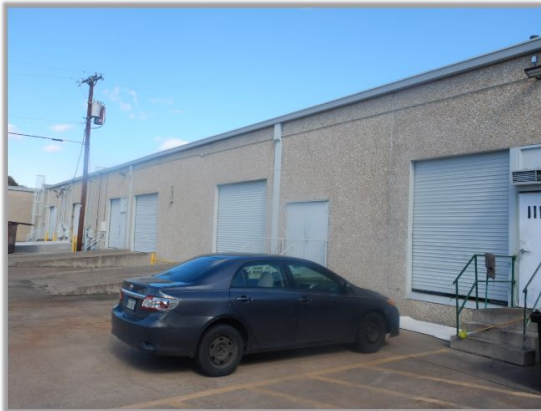
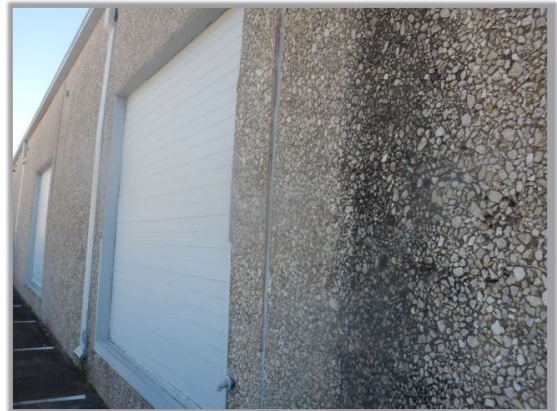
Unit 1137 (3) garage doors

Minor damage to the garage door at unit 1137. Recommend repair or replacement as needed.
