PROPERTY INSPECTION REPORT

Concerning: 1234 Main Street, Dallas, TX 75223
(Address or Other Identification of Inspected Property)

By: Don Stafford, Lic #737 02/26/2020
(Name and License Number of Inspector) (Date)

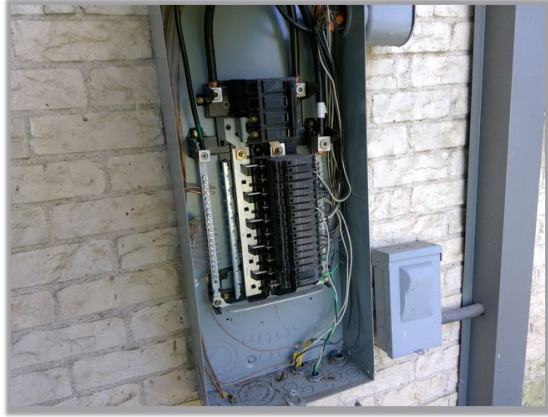
Wiring in the panel box(es) is not properly identified. Some white insulated wires are being used as ungrounded "hot" circuits. Ideally, the wiring should be properly identified with appropriately permanent markings, (electricians tape or other means). Recommend repair.
